## **Viking Energy Partnership**

### **Viking Wind Farm**

## **Technical Appendix 14.2 Borrow Pit Assessment**

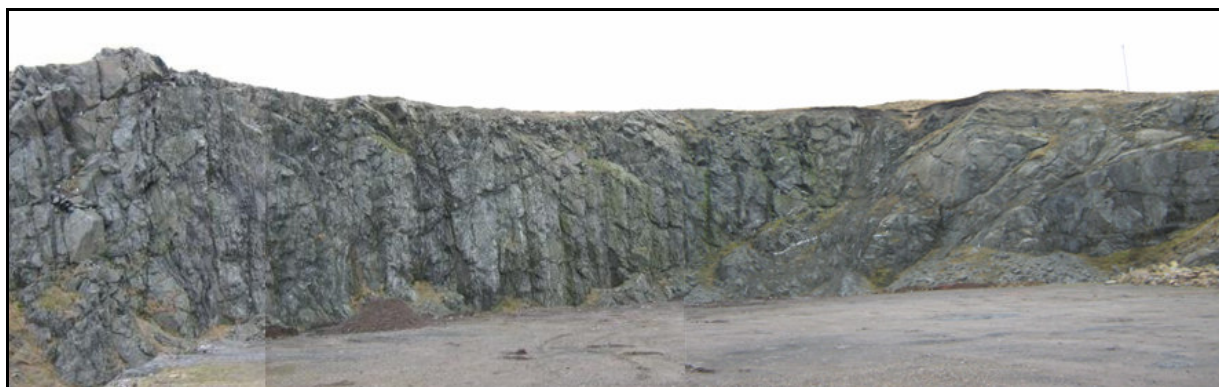
**Figure 1 Photograph of DBP01: View of main quarry face looking south-east**

This location is situated roughly halfway between two of the access routes into Delting quadrant, which makes it a good place from which to make the relatively small volume initial extractions before the borrow pits within the site itself are reached, whilst at the same time avoiding aggregate loads being transported through the settlements of Brae and Voe. The main quarry face is about 270m long and up to 20m high (Figure 1). Slope angles are in the range of 5-10° and the site is at an elevation of 15-40m above ordnance datum (AOD). Peat depths were not measured due to the difficulty of gaining access to the top of the quarry wall, but are likely to be thin.

The proposed extraction would follow the existing quarry face, cutting back into the hill to the south-east of the quarry. The lithology, shown in Figure 2, has a variable texture:

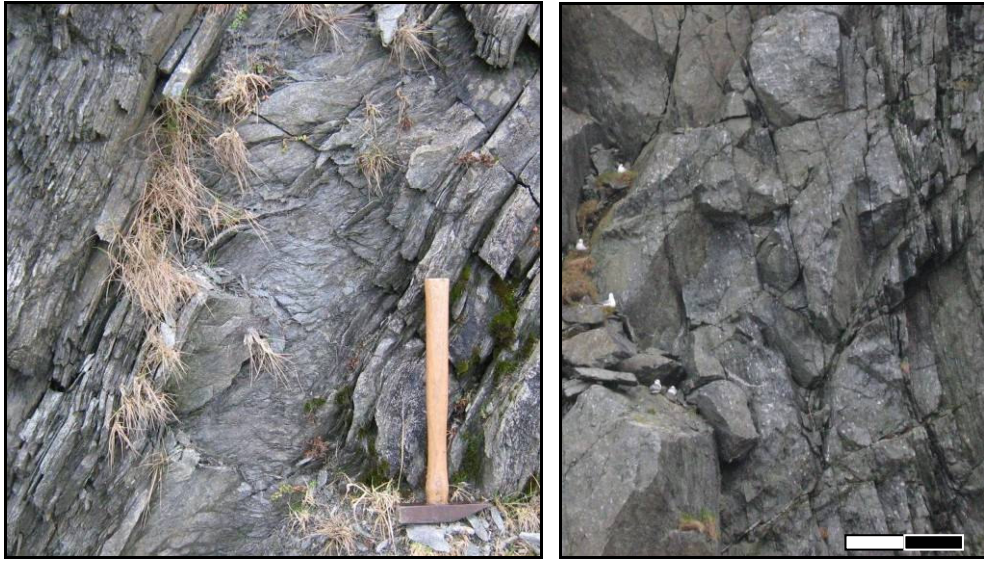
**Figure 2 Close-ups of bedrock at DBP01: (a) Variable fabric, fracturing and shearing (hammer 30cm long); (b) Massive gneissose banding (scale bar 2m).**

- Dark grey;
- Medium- to coarse-grained;
- Well-foliated and platy, with foliation varying from mm-scale to over 1m;
- Some fracturing and jointing;
- Fresh to discoloured;
- Schistose GNEISS;
- Strong to very strong.

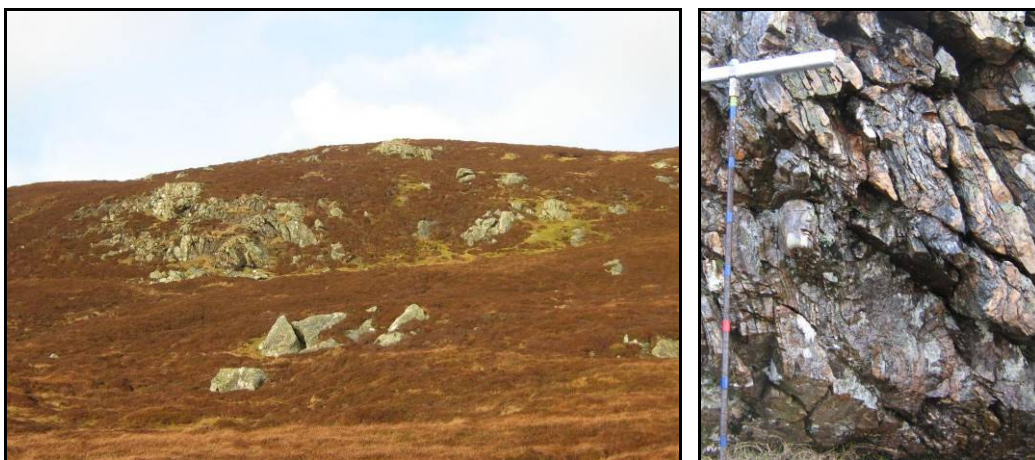
**Figure 3 Photographs of DBP02: (a) Overview of site from the south-west; (b) Close-up of bedrock, showing foliation and jointing (peat probe marked in 10cm divisions)**

Borrow Pit DBP02 (grid reference HU 3771 6691) lies on the south-west access route into Delting quadrant, 2.4km south-east of Brae. It is situated on a moderately steep west to south-west facing slope with extensive but scattered rock outcrop (Figure 3a). Good outcrop extends north from the proposed site for at least 400m, allowing for flexibility of position should this be required. The site elevation ranges between 90 and 125m AOD with slope angles in the range of 5-25°. Peat depths are variable across the site, usually <0.7m but in some places are over 1m.

- Pale to dark grey;
- Medium- to coarse-grained;
- Strongly banded, usually 1-10cm wide, with folding, some jointing and massive quartz veins present;
- Fresh to discoloured;
- Gneissose SCHIST;
- Strong.

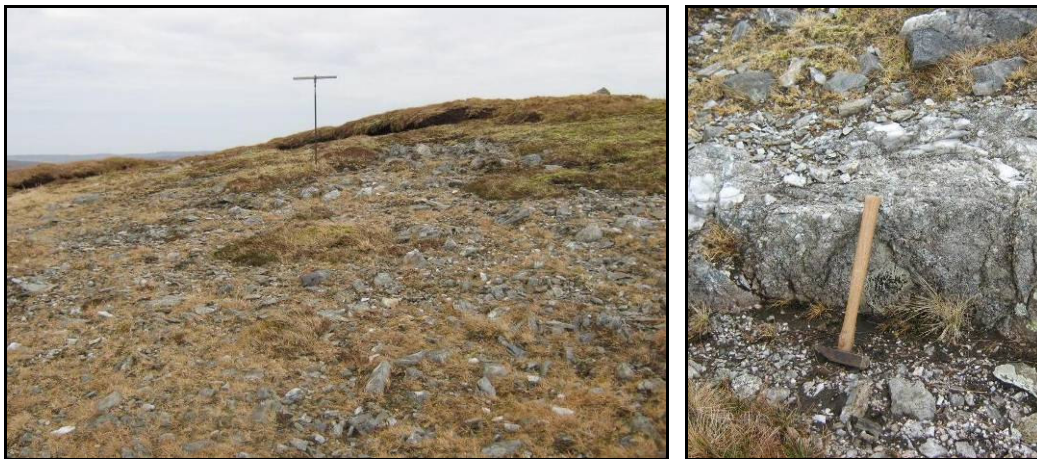
**Figure 4 Photographs of DBP03: (a) View uphill over site showing mineral soil exposure (peat probe 1m long); (b) Close-up of rock-step (hammer 30cm long).**

Borrow Pit DBP03, grid reference HU 4065 6985, lies in the central section of Delting quadrant on the north-east ridge of the Hill of Dale and near to the proposed track route between Turbines 12 and 16. The site takes advantage of the break-in-slope on the northern side of the ridge and covers an area of exposed mineral soil with bedrock outcrops (Figure 4). Slope angles range between  $<1^\circ$  and  $15^\circ$ , and the site is at an elevation of 195-215m AOD. Recorded peat depths around this site indicate it is mostly fairly shallow at  $<0.5\text{m}$ .

The proposed borrow pit would lie along an axis running NNW–SSE into the side of the hill. The rock identified at this site (Figure 4b) is:

- Pale grey to white;
- Medium- to coarse-grained;
- Well-developed pervasive platy foliation, usually 5-10mm wide, with some folding and jointing;
- Fresh;
- QUARTZITE & PSAMMITE;
- Strong to very strong.

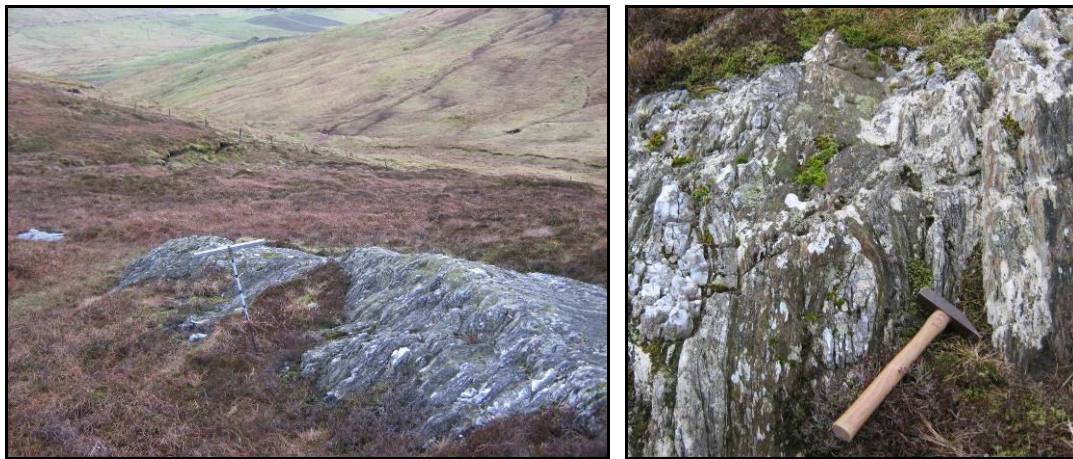
**Figure 5 Photographs of CBP01: (a) View north-west over site showing rocky ridge; (b) Close-up of rock outcrop (hammer 30cm long)**

The proposed borrow pit lies on the break-in-slope with a main axis running NNW–SSE. There are small outcrops near the top of the site, forming rocky ridges (Figure 5a) with small craggy outcrops towards the northern margin of the site. The lithology present is shown in Figure 5b and is:

- Pale to dark grey;
- Medium- to coarse-grained;
- Very strongly foliated with distinct colour banding, pegmatitic areas and quartz veins, tight folds visible in places;
- Fresh to discoloured;
- Gneissose SCHIST;
- Moderate to strong.

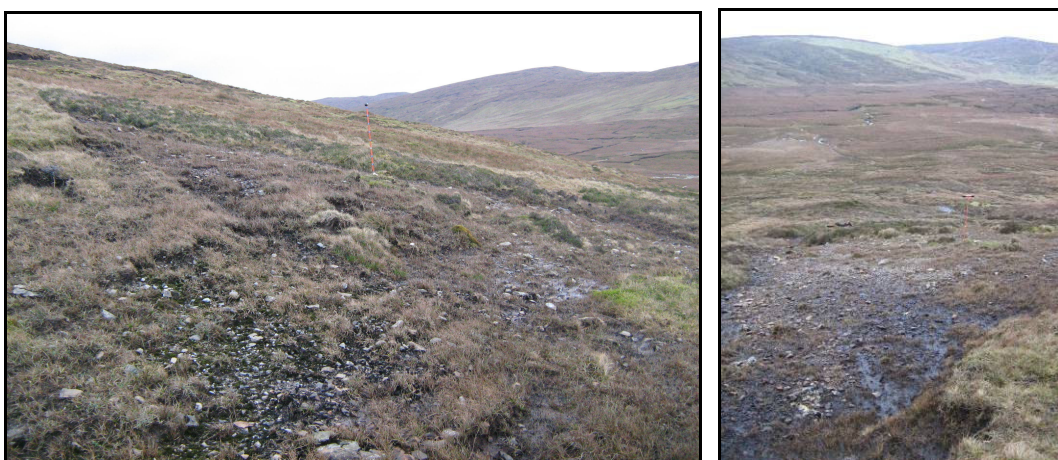
**Figure 6 Photographs of KBP01: (a) View across the site to the south-west; (b) View downhill over the site to the north-west (peat probe 1m)**

Peat cover is very variable, from 0.6m in the areas of mineral soil, to >1m both above and below the proposed site. It is also likely that the upper part of the bedrock is significantly affected by weathering, although cannot be confirmed without intrusive investigation.

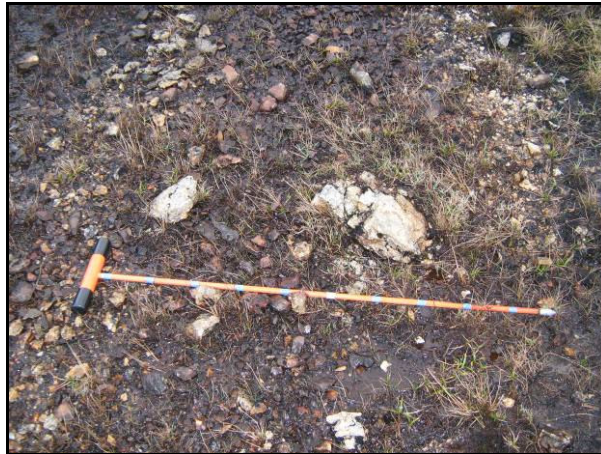
**Figure 7 Photograph of KBP01: close-up of mineral soil (peat probe 1m)**

The proposed borrow pit lies along a NW–SE axis to take advantage of the slope angle. In the absence of exposed bedrock, the lithology has been described using mineral soil exposure alone, as shown in Figure 7, and is consequently incomplete:

- Pale grey;
- Medium- to coarse-grained;
- Well-banded;
- Granitic GNEISS;
- Strong to very strong.

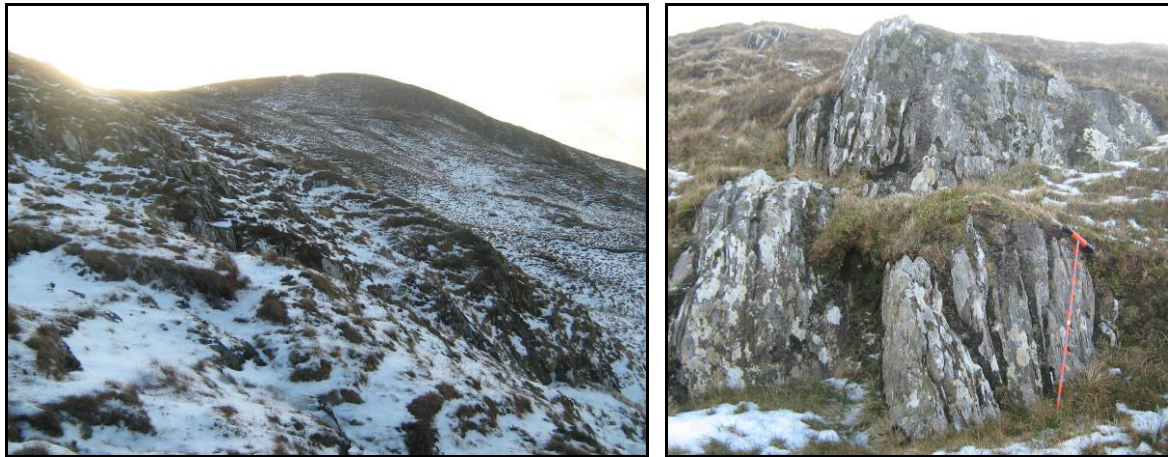
**Figure 8 Photographs of KBP02: (a) View south-west across borrow pit site to Scalla Field; (b) Rocksteps exposed on the northern end of the ridge (peat probe 1m)**

Borrow Pit KBP02 is situated in the north-central section of Kergord quadrant at grid reference HU 3918 5763. It lies on the northern ridge of Scalla Field leading down to the col at Scallafeld Scord and is adjacent to the proposed track route. The site is at an altitude of 205-240m AOD with slope angles ranging from 8 to 30°. Peat cover is very variable, from <0.1m adjacent to outcrop to >1m in other sections.

The proposed borrow pit lies on the western side of the ridge to take advantage of the steeper rocky slopes in this area (Figure 8a). Bedrock is exposed across the site as a series of small rocksteps (Figure 8b), rough slabs and rocky knolls, becoming more poorly exposed on flatter ground to both the east and the west. The lithology is:

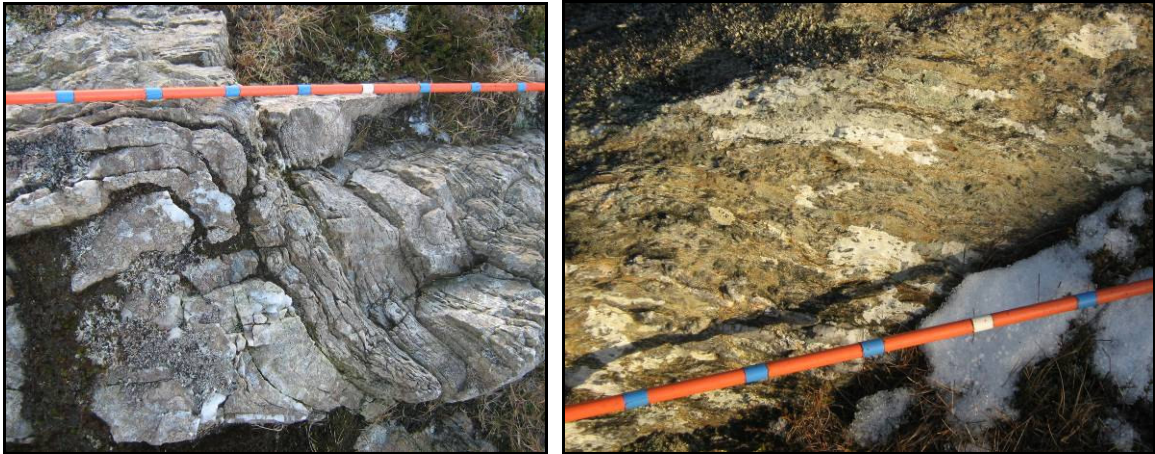
**Figure 9. Photographs of KBP02: (a) Close-up of folded psammite; (b) Close-up of foliated schist with porphyroblasts (scale bars marked in 10cm sections)**

- Mid- to pale grey;
- Medium to coarse-grained;
- Well-foliated with distinct folding (Figure 9a), colour banding and a porphyroblastic texture in places (Figure 9b);
- Fresh to discoloured;
- Psammitic SCHIST;
- Strong.

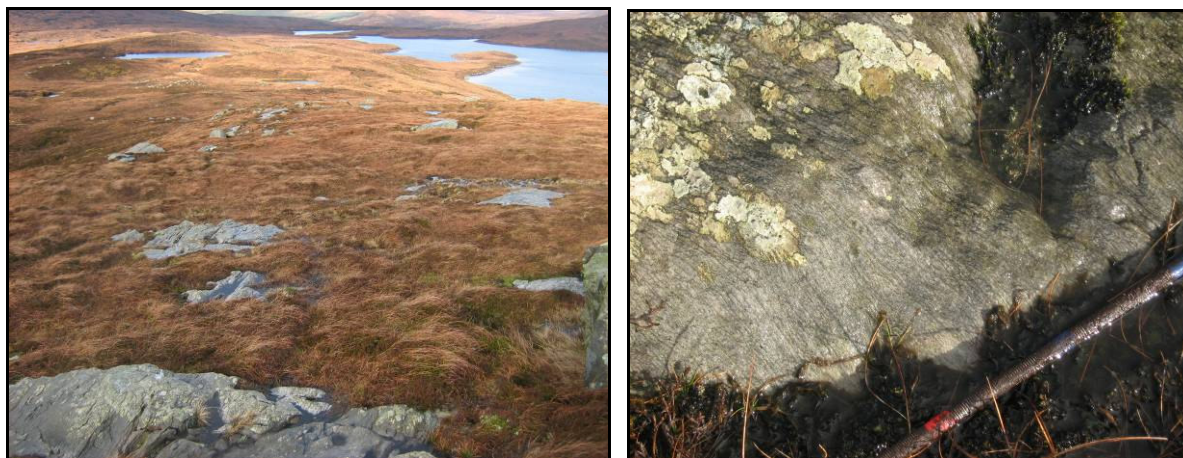
**Figure 10 Photographs of KBP03: (a) View north-west over borrow pit site; (b) Close-up of narrowly foliated bedrock (scale bar 20cm)**

Borrow Pit KBP03 is located in the central section of Kergord quadrant, at grid reference HU 3834 5527. It is situated on the north-west ridge of the West Hill of Weisdale which runs down to the division between Maa Water and Lamba Water. The ridge section has considerable but scattered rocky outcrop (Figure 10a), mostly as a series of rough slabs. Peat depths are quite variable, with pockets of >1m, although it is <0.6m across most of the site. The site is at an elevation of 140-170m AOD and has slope angles ranging from 2-23°.

The proposed borrow pit has an axis running NW–SE to follow the ridge line and make best advantage of the slope angles. The lithology, shown in Figure 10b, at the site is:

- Pale grey;
- Fine to medium grained;
- Very well and narrowly foliated on a mm-scale with distinct colour banding throughout;
- Fresh to discoloured;
- SCHIST & PSAMMITE;
- Strong to very strong.

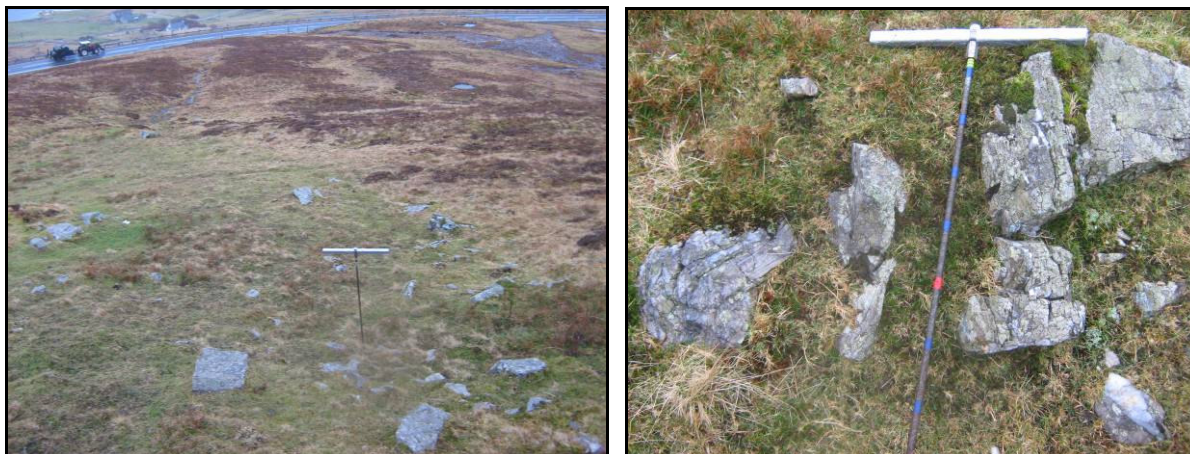
**Figure 11 Photographs of KBP04: (a) View south over borrow pit site; (b) Close-up of bedrock (peat probe 1m, marked in 10cm sections)**

- Pale grey;
- Medium to coarse-grained;
- Very well-banded with pervasive but poorly developed foliation;
- Fresh to discoloured;
- Gneissose SCHIST;
- Strong to very strong.

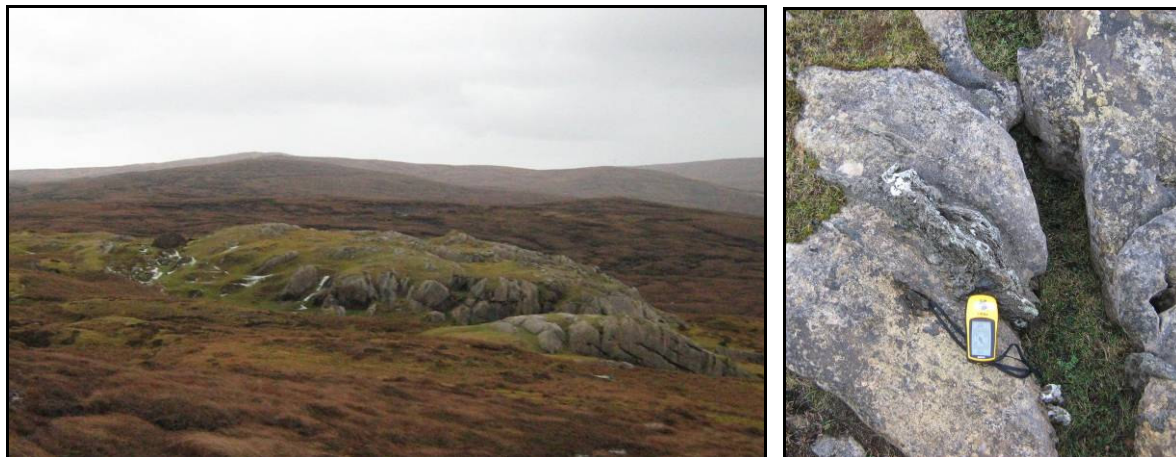
**Figure 12 Photographs of NBP01: (a) View of main outcrop looking south; (b) Close-up of marble showing jointing and included chert band (GPS handset 11cm long)**

Borrow Pit NBP01 lies at the northern end of the Nesting quadrant at grid reference HU 4198 6151. It forms the main borrow pit for the northern section of the Nesting quadrant. It is sited on the southern ridge of South Filla Runnie, cutting into the west-facing slope where there is good bedrock exposure and a suitable break-in-slope. Site elevation is between 110 and 130m AOD with slope angles up to 17°. Recorded peat depths are shallow, mostly <0.5m.

This proposed borrow pit cuts into the ridge along a ENE–WSW axis. Bedrock is exposed in a series of ice-smoothed outcrops across the top and side of the ridge with rocksteps to about 3m high (Figure 12a). The rock type is:

- Mid- to pale grey-brown;
- Fine to medium-grained;
- Well-jointed with folding and some colour banding, including small chert and pegmatite bodies;
- Fresh to discoloured;
- MARBLE;
- Strong to very strong.

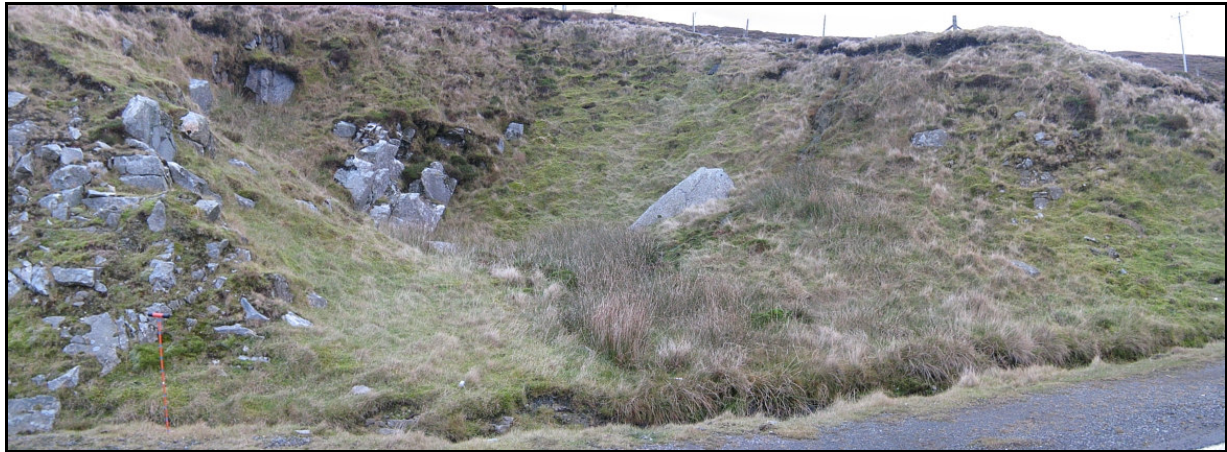
**Figure 13 Photographs of NBP03: View of existing borrow pit back wall looking east (peat probe 1m long)**

Borrow Pit NBP03, grid reference HU 4211 5619, is an existing disused borrow pit immediately east of the A970 (Figure 13). In common with NBP04, this borrow pit is situated near the main access to South Nesting as well as fairly close to the access routes to North Nesting and Mid Kame ridge in the Kergord quadrant. This makes it an excellent place from which to source aggregate for immediate access requirements, until borrow pits within the site can be reached.

The proposed extraction would extend the existing borrow pit back into the side of East Kame ridge along an E–W axis and would also widen the pit both north and south of its current position. Slope angles in the area are between 10 and 20° and the elevation ranges from 65-95m AOD. Peat depths were not measured due to difficulties of access but are likely to be shallow.

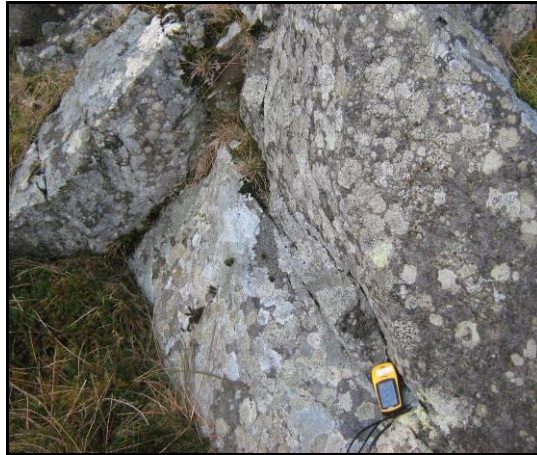
**Figure 14 Close-up of bedrock at NBP03: detail of exposed granitic bedrock showing massive nature (GPS handset 11cm long)**

- Pale grey;
- Coarse-grained;
- Massive with some jointing in places and a poorly developed foliation;
- Fresh to discoloured;
- Gneissose GRANITE;
- Strong to very strong.

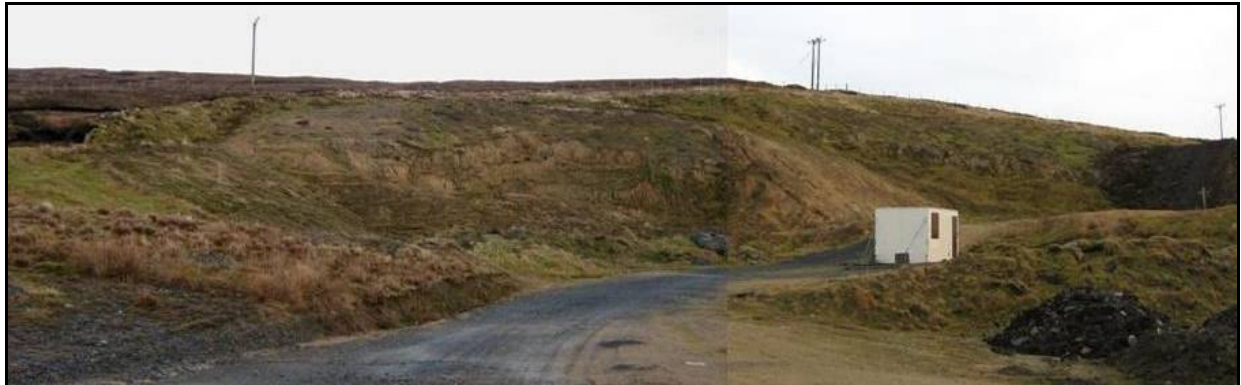
**Figure 15 Photograph of NBP04: View of main backwall of quarry looking east, showing partial back-fill at right-hand side of photograph**

Borrow Pit NBP04 is situated 300m south of NBP03, at grid reference HU 4212 5587, and is also a disused quarry. Like NBP03, it lies immediately east of the A970 and is currently disused although the extraction here was more extensive than at NBP03. The quarry has been partially back-filled (Figure 15), which restricts access to the existing quarry walls and which may require removal if the quarry is to be reopened.

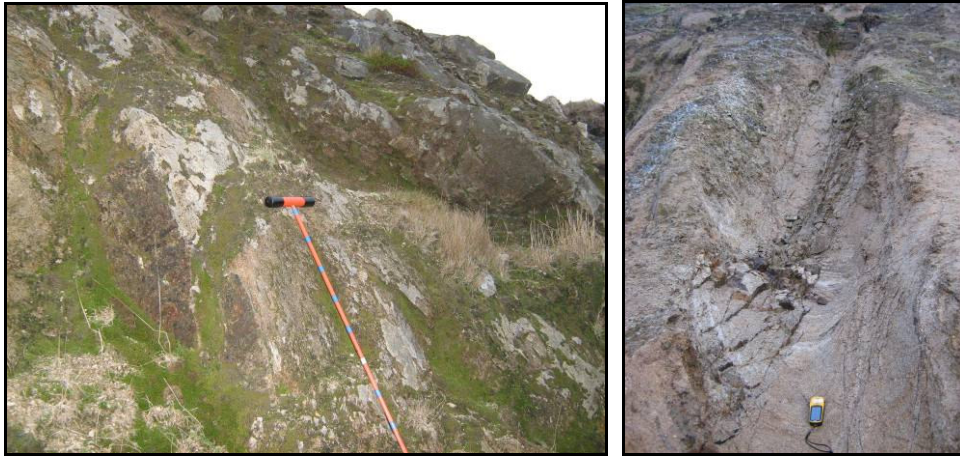
**Figure 16 Close-ups of bedrock at NBP04: (a) View of exposed bedrock in backwall of quarry (peat probe marked in 10cm sections; (b) Close-up of water-worn channel through bedrock (GPS handset 11cm long)**

The lithology present at the site is shown in Figure 16 and comprises:

- Mid- to pale brown;
- Medium- to coarse-grained;
- Heavily fractured with strong and pervasive colour banding, quartz veins in places;
- Variably discoloured to disintegrated, decomposed to a sand-like consistency in places;
- Gneissose GRANITE;
- Moderately weak to strong.

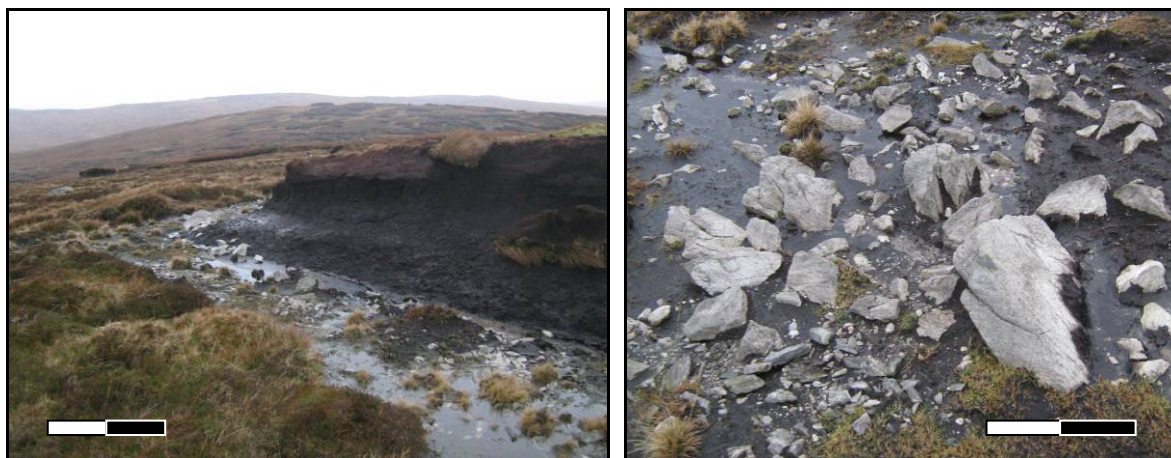
**Figure 17 Photographs of NBP05: (a) View across site looking north (scale bar 1m); (b) Close-up of mineral soil (scale bar 30cm)**

Borrow Pit NBP05 lies near the south end of Nesting quadrant, near the main access route into the site, at grid reference HU 4380 5684. It is situated just north of the summit of the Dud of Flamister and takes advantage of the slope to the east side of the hill. The area has been subject to extensive peat erosion, with large sections of the hilltop eroded to the mineral soil (Figure 17a), some of which has begun to revegetate. The site is at an altitude of 155-170m AOD with slope angles ranging between 1 and 15°. Recorded peat depths are up to 0.6m although some remnant peat banks on the hill summit may be up to 1.5m thick.

- Pale to mid-grey;
- Medium-grained;
- Well-foliated and platy with some limited colour banding;
- Fresh to discoloured;
- PSAMMITE;
- Strong to very strong.

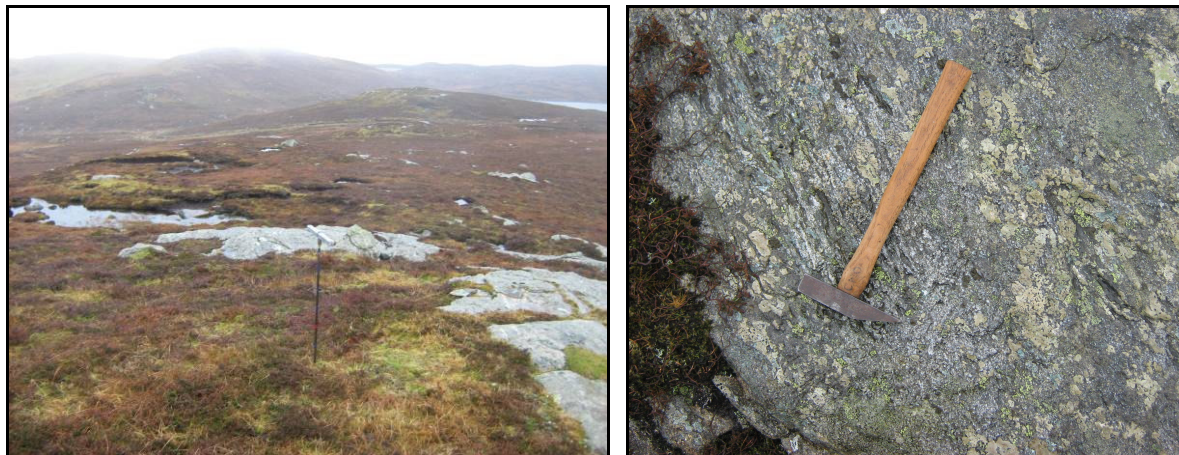
**Figure 18 Photographs of NBP06: (a) View south down the ridge towards the access track (peat probe 1m); (b) Close-up of bedrock (hammer 30cm)**

Borrow Pit NBP06 is located on the eastern access route into the Nesting quadrant at grid reference HU 4656 5629. It lies on a well-defined rocky ridge with bedrock exposed as small rocksteps and slabs (Figure 18a). Slope angles range between  $<1$  and  $20^\circ$  and the site is at an altitude of 75-100m AOD. Peat cover is variable across the site; on the ridge is it mostly no more than 0.5m but is deeper towards the edges and away from the rocky outcrops.

The proposed borrow pit is oriented N–S to take advantage of the steeper slope and thinner peat overburden on this side of the ridge. The lithology exposed at the site (Figure 18b) is:

- Mostly mid- to pale grey;
- Medium- to coarse-grained;
- Well-banded with jointing, folded in places;
- Fresh to discoloured;
- Granitic GNEISS;
- Strong to very strong.

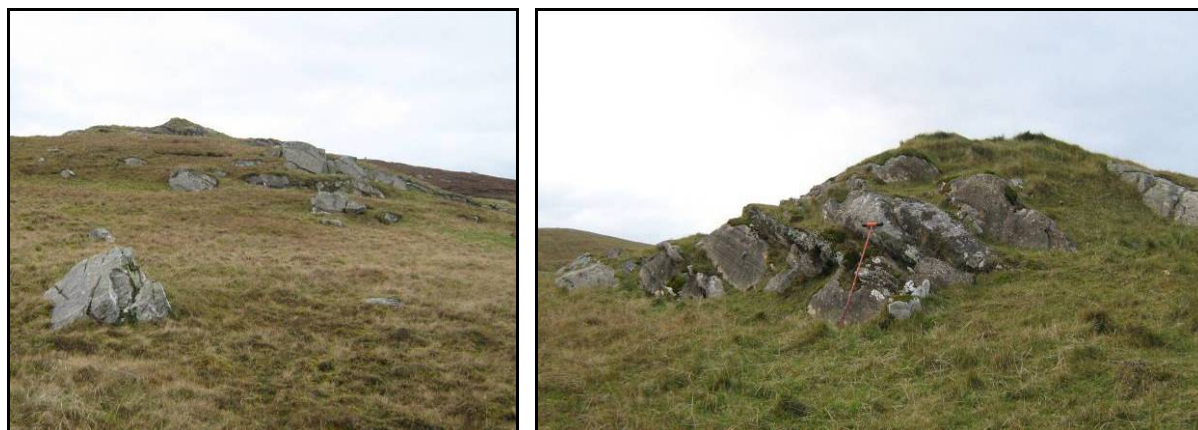
**Figure 19 Photographs of NBP09: (a) View W over site showing rocky knolls and rocksteps; (b) Knoll at top of site (peat probe 1m)**

Borrow Pit NBP09 is a small borrow pit site beside the eastern access route into the Nesting quadrant and immediately adjacent to the B9075. It is situated at grid reference HU 4651 5575 on the lower slopes of the Hill of Skellister. Bedrock is exposed in a series of rocky knolls and small rocksteps across the slope (Figure 19) and down towards the sea. The site is at an elevation of 40-50m AOD and slope angles range from 3 to 20°. Peat cover across the site ranges from <0.1m in areas adjacent to rock outcrops to >1m in the more boggy sections.

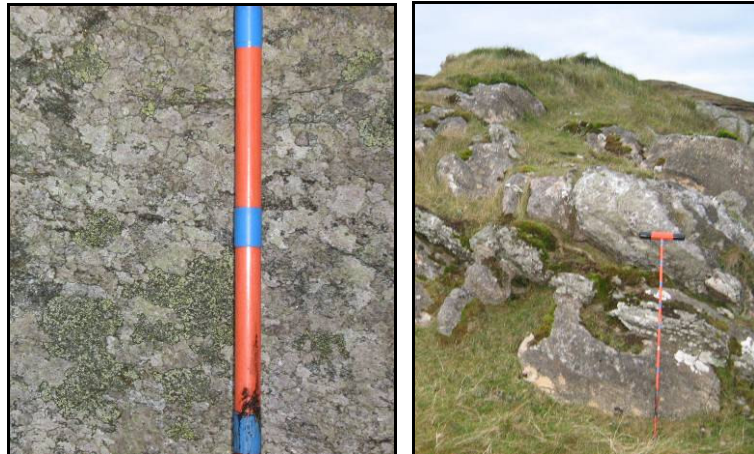
**Figure 20 Close-ups of bedrock at NBP09: (a) Gneissic bedrock in lower part of site (scale 20cm); (b) Part of marble outcrop showing banded texture (peat probe 1m)**

The main axis of the proposed borrow pit runs nearly E–W to take advantage of the natural slope angles. Two rock types are exposed at the site. At the lower, eastern, end the lithology (Figure 20a) is:

- Mostly pale grey;
- Medium- to coarse-grained;
- Well-jointed with some gneissose foliation and colour banding visible in places;
- Fresh to discoloured;
- Granitic GNEISS;
- Strong to very strong.

- Pale brown to grey;
- Fine to medium-grained;
- Well-banded with some jointing;
- Fresh to discoloured;
- MARBLE;
- Strong to very strong.
