Viking Wind Farm

Technical Appendix 14.3 Stream Crossing Guidance

February 2009

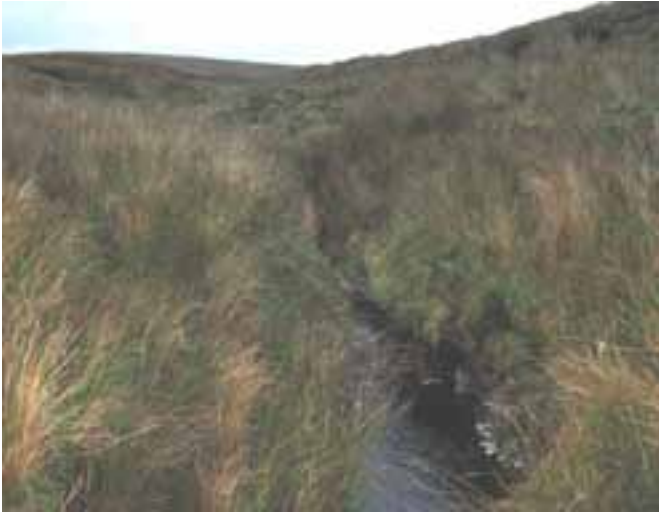
Viking Wind Farm Survey of Stream Crossings			
<p>Crossing: DS03</p> <p>Route: Access track between A968 & D16</p> <p>Catchment ID: 5</p> <p>Watercourse: Burn of Moorfield, tributary burn to North Burn</p> <p>NGR: HU 42524 72280</p> <p>Description: Small stream around 0.5m wide within broad flood channel 20m wide by 5m deep with a water depth of 0.3m. Peat bed with cobbles and boulders.</p> <p>CAR Category: Small</p> <p>Catchment Area: 0.53 km² (upstream of crossing location)</p> <p>Ecology: Migratory fish, unlikely. Mammals, none</p> <p>Crossing Type: New crossing: Rectangular culvert.</p>

Looking across stream Viking DS03 across.jpg		Looking downstream Viking DS03 down.jpg

Looking upstream Viking DS03 up.jpg

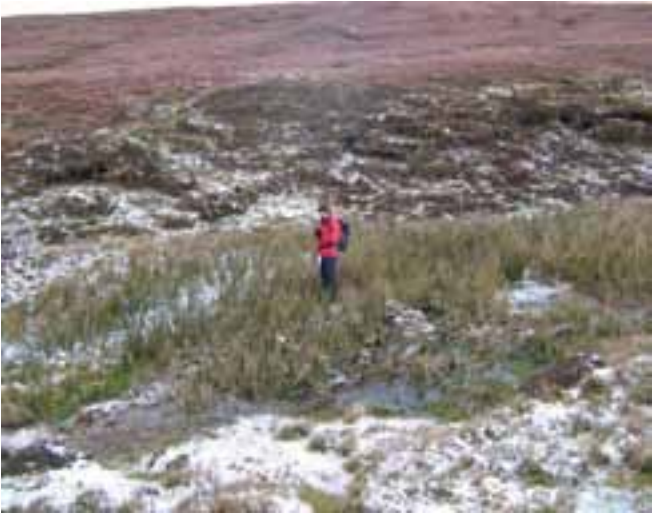
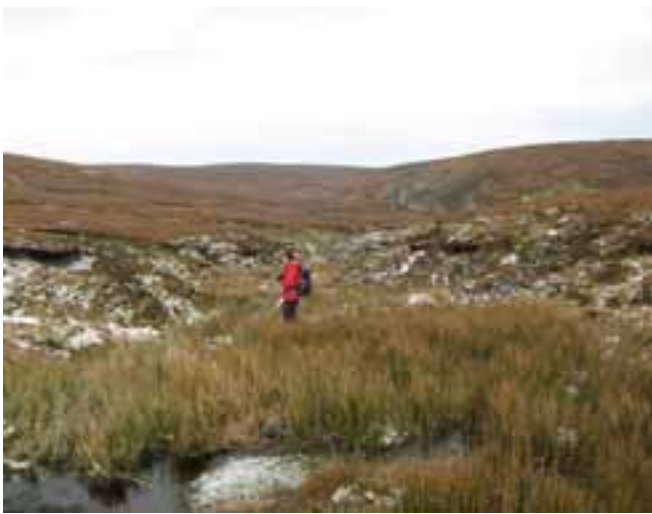
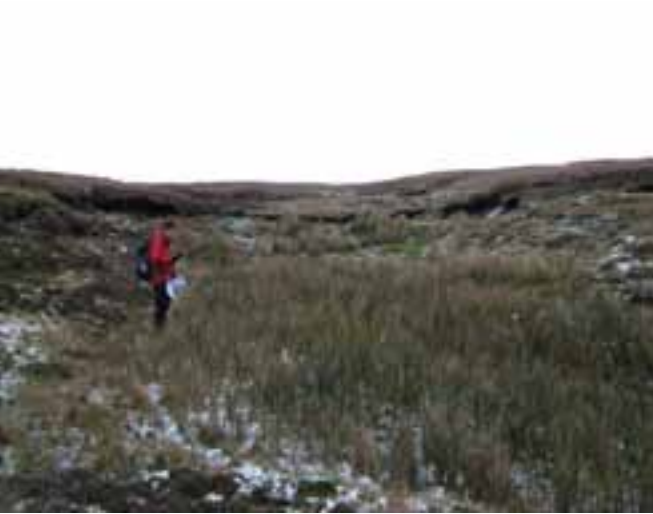
Viking Wind Farm Survey of Stream Crossings		
<div><div>Crossing: DS04</div><div>Route: Access track between D10 & D11</div><div>Catchment ID: 5</div><div>Watercourse: Burn of Laxobigging</div><div>NGR: HU 41173 71040</div><div>Description: Boggy area 20m wide by 5m deep with a water depth of 0.3m. No distinct watercourse, peat bed with some exposed rock.</div><div>CAR Category: Medium</div><div>Catchment Area: 0.26 km² (upstream of crossing location)</div><div>Ecology: Migratory fish, unlikely. Mammals, none</div><div>Crossing Type: New crossing: Multiple circular culverts.</div></div>

Looking across stream Viking DS04 across.jpg	Looking downstream Viking DS04 down.jpg	Looking upstream Viking DS04 up.jpg

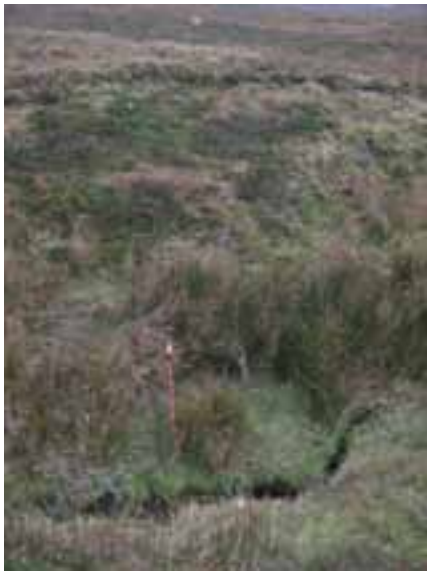
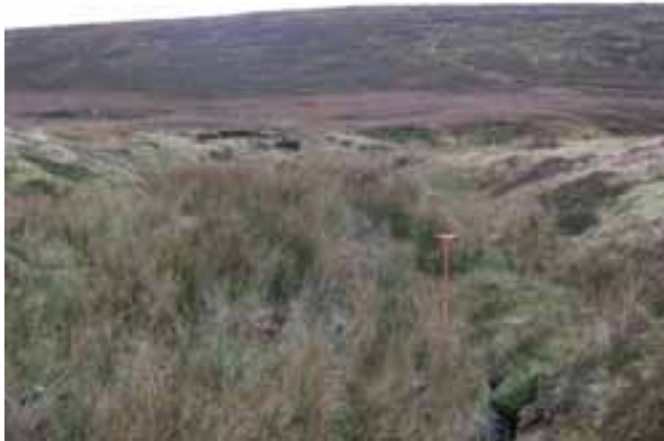
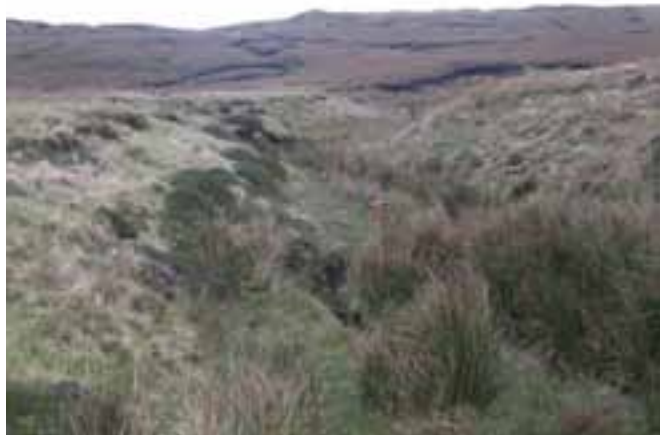
</div><div>Looking across stream</div><div>Viking DS06 across.jpg</div></div>	<div><div>

Viking Wind Farm Survey of Stream Crossings		
<div><div><div>Crossing:</div><div>Route:</div><div>Catchment ID:</div><div>Watercourse:</div><div>NGR:</div><div>Description:</div><div>CAR Category:</div><div>Catchment Area:</div><div>Ecology:</div><div>Crossing Type:</div></div><div><div>DS06</div><div>Track between D7 & D8</div><div>5</div><div>Burn of Oxnabool feeder burn to Burn of Laxobigging</div><div>HU 40203 70602</div><div>Small stream 0.4m wide by 1m deep, water level 0.2m. Stream within a larger flood channel about 2-3m wide. Peaty bed with cobbles and large rocks on bed.</div><div>Medium</div><div>0.51 km² (upstream of crossing location)</div><div>Migratory fish, unlikely. Mammals, none.</div><div>New crossing: Rectangular culvert.</div></div></div>	<div><div>Mid Field</div><div>eadow of Fitchin</div><div>DS06</div><div>D5</div><div>D7</div><div>D8</div><div>D9</div><div>D11</div><div>DS05</div><div>DS07</div><div>40</div><div>41</div><div>5</div></div> <div>© Licence number 100024344</div> <div>Not to Scale</div>

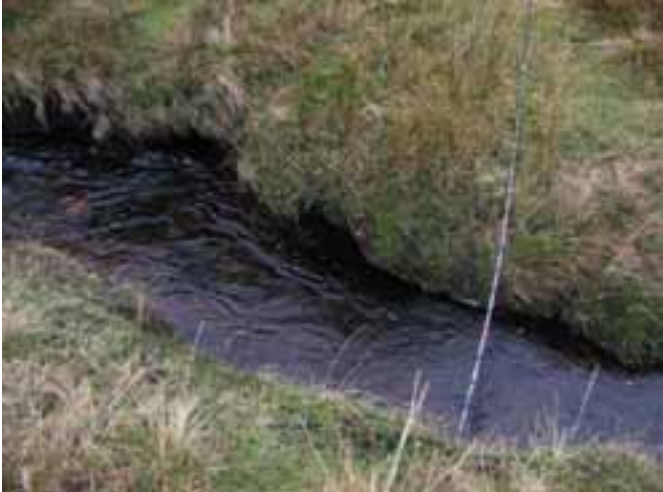
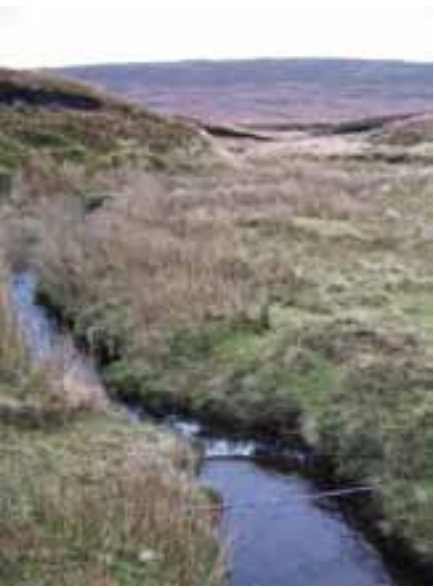
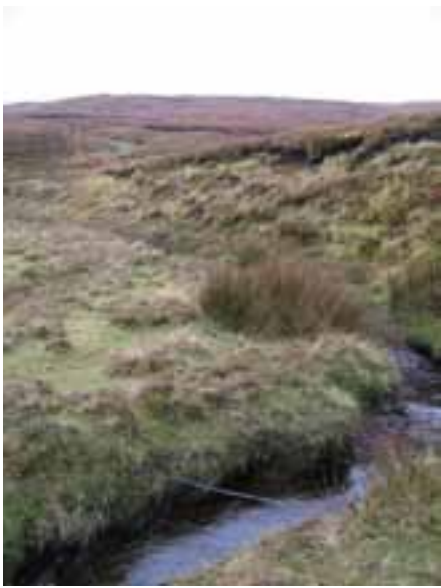
Looking across stream	Looking across stream	Looking upstream
Viking DS07 across.jpg	Viking DS07 across.jp	Viking DS07 up.jpg

Viking Wind Farm Survey of Stream Crossings		
<div><div><div>Crossing:</div><div>Route:</div><div>Catchment ID:</div><div>Watercourse:</div><div>NGR:</div><div>Description:</div></div><div><div>CAR Category:</div><div>Catchment Area:</div><div>Ecology:</div><div>Crossing Type:</div></div></div> <div><div>DS07</div><div>Track between D4, D6 & D7</div><div>5</div><div>Burn of Easterbutton</div><div>HU 39658 70188</div><div>Channel 1.2m wide by roughly a 1m high with a water depth of 0.7m and a rocky bed. In a valley up 25m in width.</div><div>Medium</div><div>1.15 km² (upstream of crossing location)</div><div>Migratory fish, present. Mammals, none.</div><div>New crossing: Rectangular culvert.</div></div>

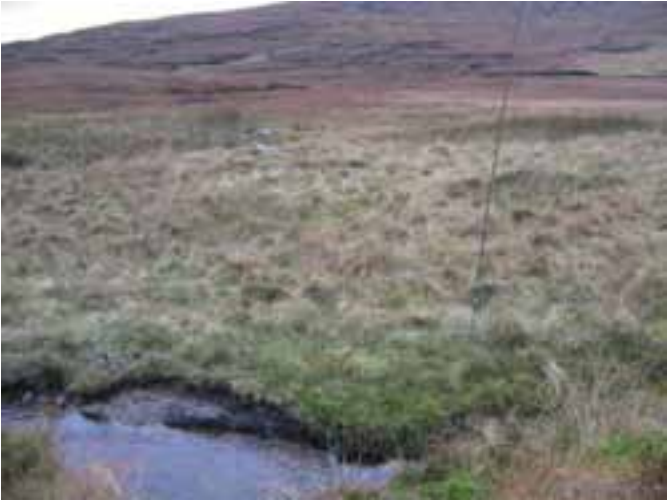
Viking Wind Farm Survey of Stream Crossings		
<div><div><div>Crossing: DS11</div><div>Route: Track between D30 & D31</div><div>Catchment ID: 9</div><div>Watercourse: Unnamed tributary to Burn of Skelladale</div><div>NGR: HU 39230 67650</div><div>Description: Small, poorly defined stream, boogy channel rather than a stream in places. Channel up 0.8m wide by 0.2m deep, with a water depth of 0.1m. Medium sized stone bed and grass banks.</div></div><div><div>CAR Category: Small</div><div>Catchment Area: 0.33 km² (upstream of crossing location)</div><div>Ecology: Migratory fish, none. Mammals, none</div><div>Crossing Type: New crossing: Circular culvert</div></div></div>

Looking across stream	Looking downstream	Looking upstream
Viking DS11 across 2.jpg	Viking DS11 down.jpg	Viking DS11 up.jpg

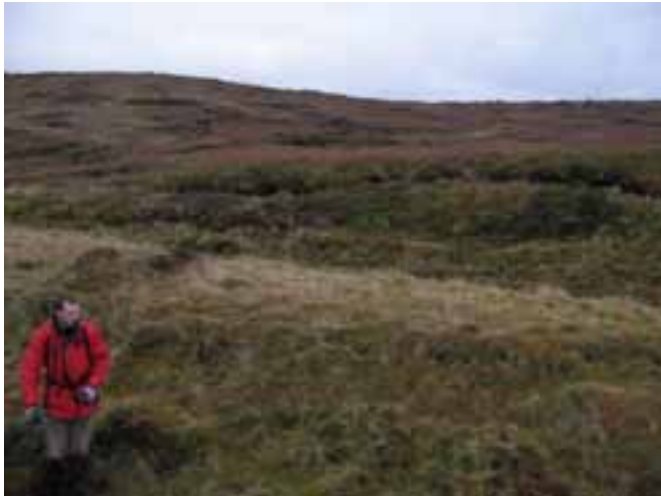
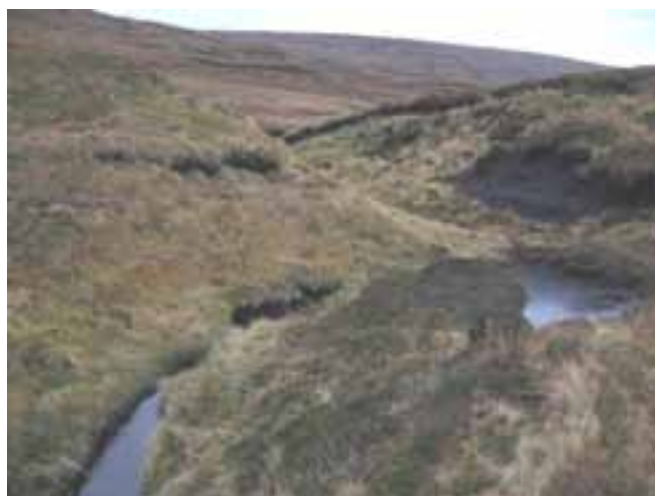
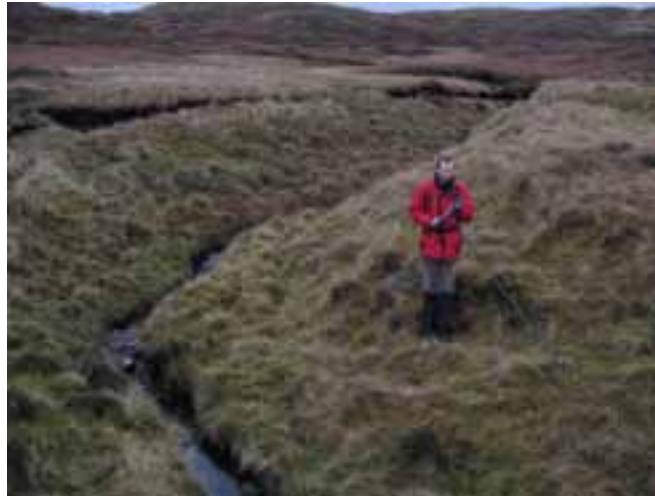
</div> <div>Looking across stream</div> <div>Viking DS12 across 2.jpg</div>	<div>

Viking Wind Farm Survey of Stream Crossings		
<div><div><div>Crossing:</div><div>Route:</div><div>Catchment ID:</div><div>Watercourse:</div><div>NGR:</div><div>Description:</div><div>CAR Category:</div><div>Catchment Area:</div><div>Ecology:</div><div>Crossing Type:</div></div><div><div>DS12</div><div>Track between D30 & D31</div><div>9</div><div>Unnamed tributary burn to Burn of Skelladale</div><div>HU 39324 67507</div><div>Small stream up to 0.5m wide in well-defined U- shaped channel. Flood channel up to 8m wide and 2.6m high, with a water depth of 0.2m. Peat bed with some cobbles. Peat banking which is slightly undercut in places.</div><div>Small</div><div>0.25 km² (upstream of crossing location)</div><div>Migratory fish, none. Mammals, none</div><div>New crossing: Rectangular culvert / arch</div></div></div>	<div>

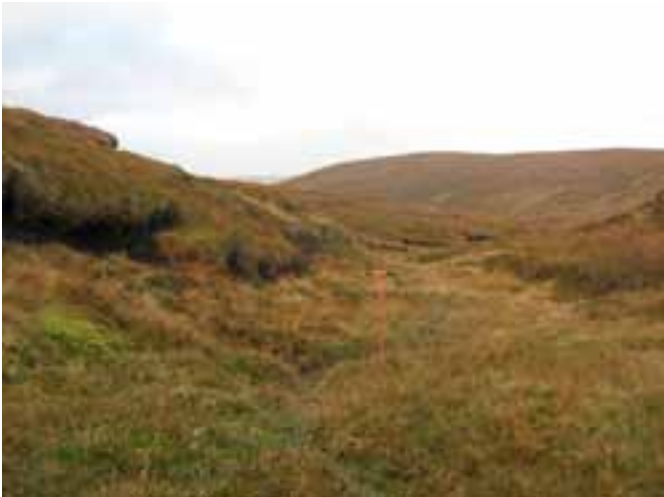
Viking Wind Farm Survey of Stream Crossings		
<div><div>Crossing: DS14</div><div>Route: Track between D30 & D31</div><div>Catchment ID: 9</div><div>Watercourse: Unnamed tributary burn to Burn of Skelladale</div><div>NGR: HU 38638 67059</div><div>Description: Small stream 0.5m wide in small to medium stream in channel 0.2-2m wide and 0.6-0.8m deep with a water level of 0.2m. Peat bed and banking.</div><div>CAR Category: Small</div><div>Catchment Area: 0.31 km² (upstream of crossing location)</div><div>Ecology: Migratory fish, none. Mammals, none</div><div>Crossing Type: New crossing: Circular culvert</div></div>

Looking across stream Viking DS14 across 2.jpg	Looking downstream Viking DS14 down.jpg	Looking upstream Viking DS14 up.jpg

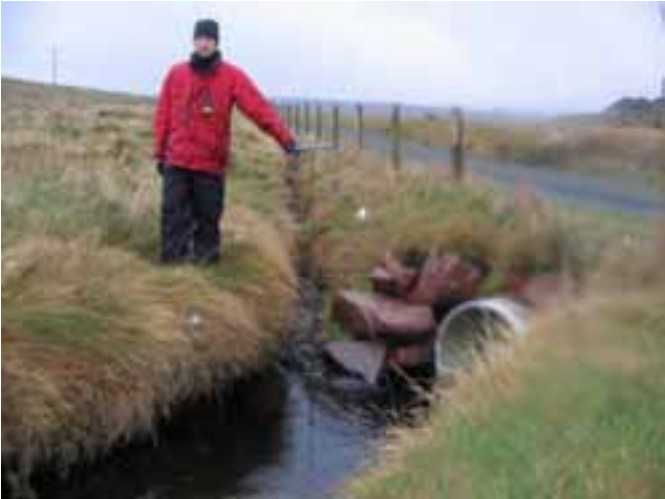
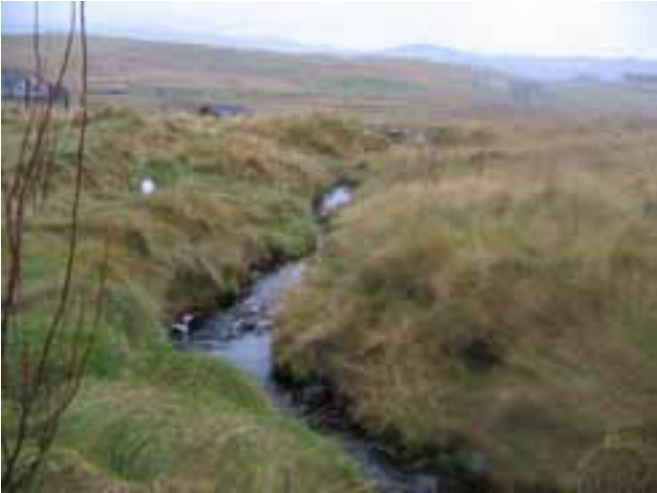
</div> <div>Looking across stream</div> <div>Viking DS15 across 2.jpg</div>	<div>

Viking Wind Farm Survey of Stream Crossings		
<div><div><div><div>Crossing:</div><div>Route:</div><div>Catchment ID:</div><div>Watercourse:</div><div>NGR:</div><div>Description:</div></div><div><div>CAR Category:</div><div>Catchment Area:</div><div>Ecology:</div><div>Crossing Type:</div></div></div><div><div>DS15</div><div>Site access between A970 and D31</div><div>26</div><div>Foulawick Burn</div><div>HU 36700 66229</div><div>Medium stream in well-defined channel up to 2.4 m wide by 1m deep and a water depth of 0.2m. Bare rock bed. The burn culverted under existing road.</div><div>Medium</div><div>0.50 km² (upstream of crossing location)</div><div>Migratory fish, likely. Mammals, none</div><div>Probably requiring upgrade of existing crossing: Rectangular culvert</div></div></div>	<div>

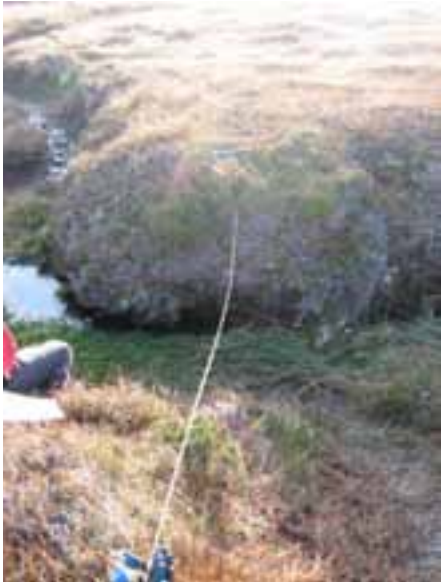
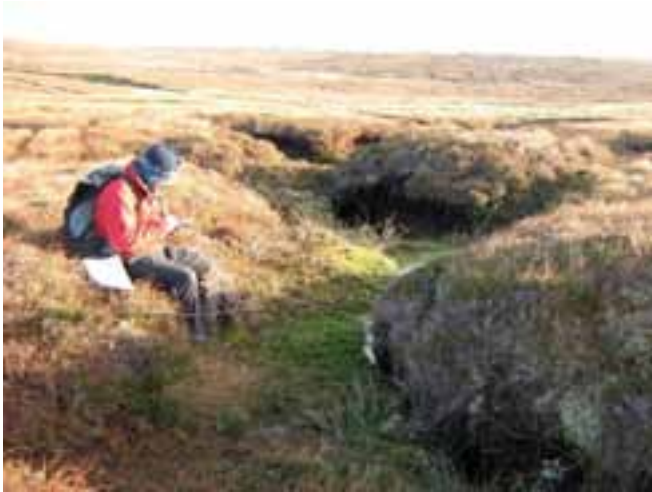
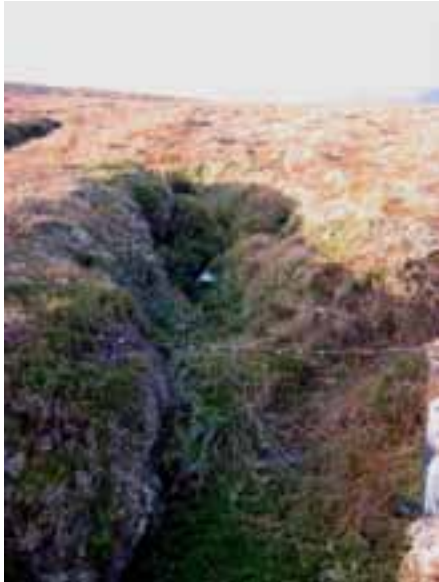
Viking CS01 across 1.jpg	Viking CS01 down.jpg	Viking CS01 up.jpg

Looking across stream	Looking downstream	Looking upstream

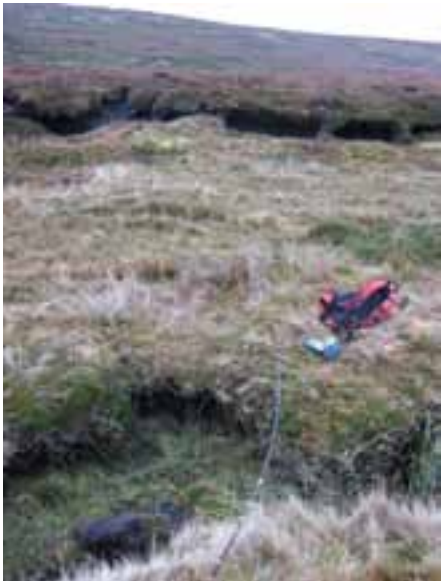
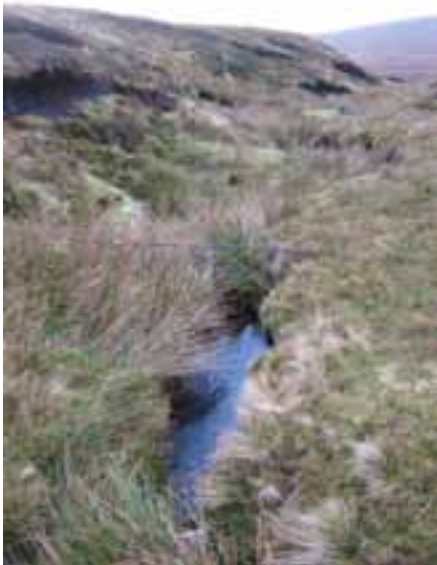
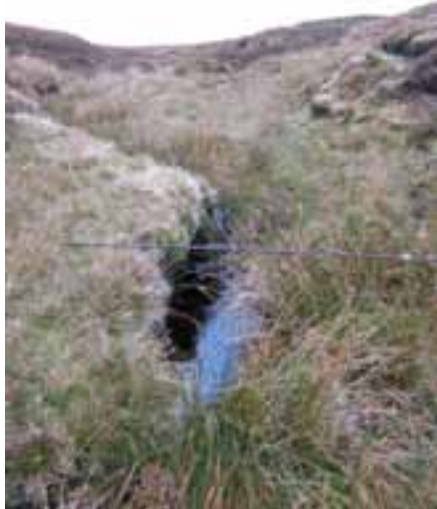
Viking Wind Farm Survey of Stream Crossings		
<div><div><div>Crossing: CS02</div><div>Route: Between C34 & C35</div><div>Catchment ID: 1</div><div>Watercourse: Unnamed tributary burn to Seggie Burn</div><div>NGR: HU 42652 66278</div><div>Description: Small channel 0.04-0.08m wide by 1m deep. Water depth 0.2m deep. Fine silt and peat bed and peat banking.</div></div><div><div>CAR Category: Small</div><div>Catchment Area: 0.56 km²</div><div>Ecology: Migratory fish, unlikely. Mammals, none</div><div>Crossing Type: New crossing: Rectangular culvert</div></div></div>

Looking across stream	Looking downstream	Looking upstream
Viking CS02 across 1.jpg	Viking CS02 down.jpg	Viking CS02 up.jpg

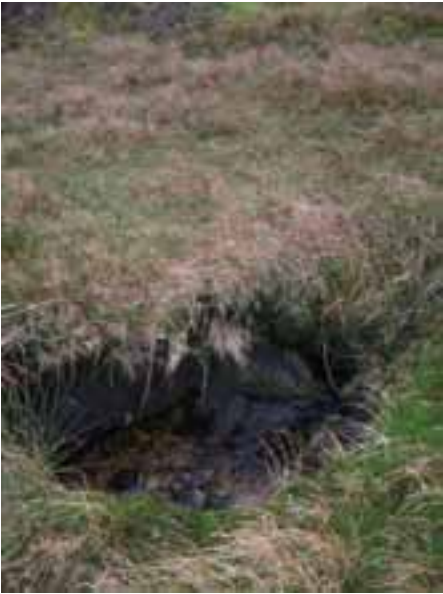
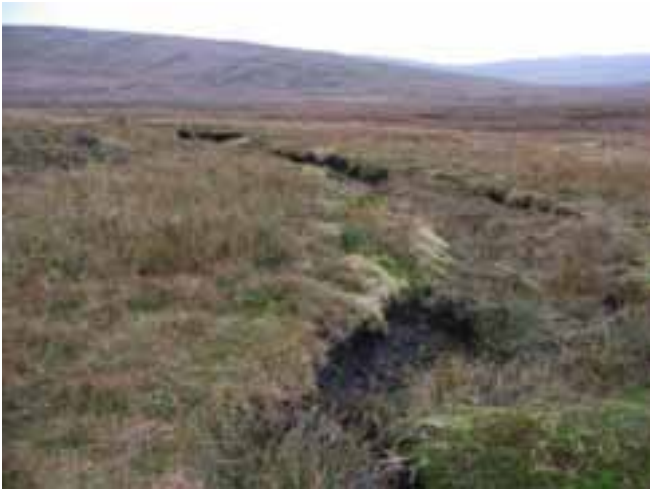
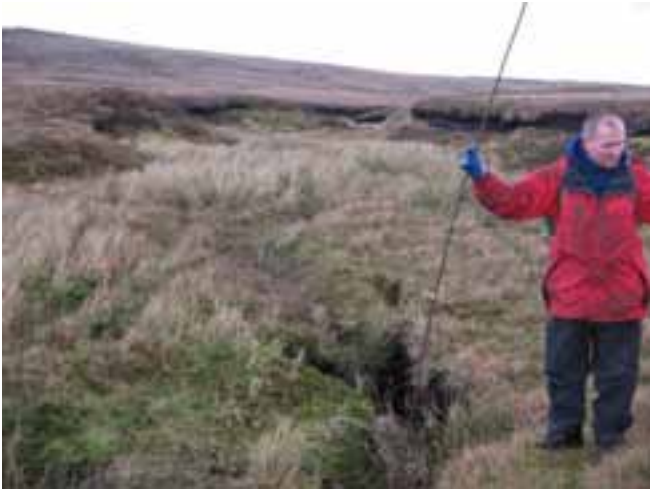
Viking Wind Farm Survey of Stream Crossings		
<div><div><div>Crossing: CS03</div><div>Route: Between C35 & C36</div><div>Catchment ID: 1</div><div>Watercourse: Unnamed tributary to Seggie Burn</div><div>NGR: HU 42858 66027</div><div>Description: Small stream/peat pipe. Overground channel 1m wide by 1.5m deep. Flood channel 16m wide. Water depth 0.2m deep. Fine silt, cobble and peat bed and peat banking. Collapsed peat pipe which looks quite unstable.</div></div><div><div>CAR Category: Small</div><div>Catchment Area: 0.24 km²</div><div>Ecology: Migratory fish, none. Mammals none</div><div>Crossing Type: New crossing: Circular pipe</div></div></div>

<p>Looking across stream</p> <p>Viking CS03 across 1.jpg</p>

<p>Looking downstream</p> <p>Viking CS03 down.jpg</p>

<p>Looking upstream</p> <p>Viking CS03 up.jpg</p>

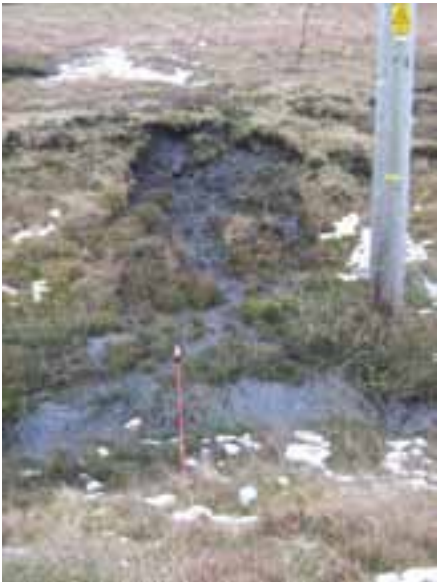
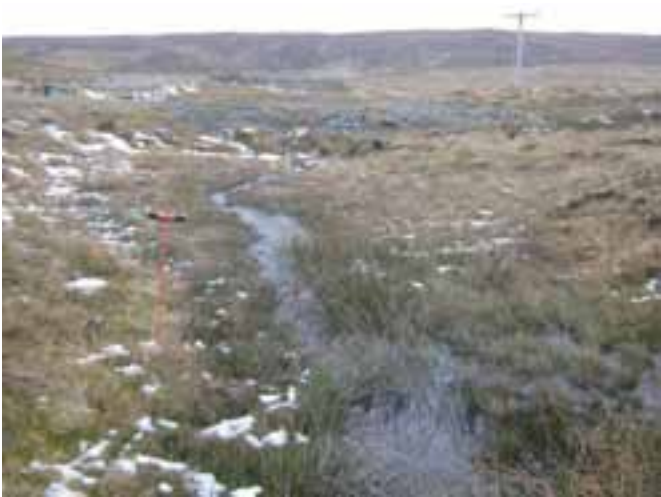
Viking Wind Farm Survey of Stream Crossings	
<div><div>Crossing: KS01</div><div>Route: Site access track just off B9071</div><div>Catchment ID: 8</div><div>Watercourse: Unnamed feeder burn to Burn of Kirkhouse</div><div>NGR: HU 39188 62220</div><div>Description: Exiting circular steel culvert 900mm in diameter under existing track. Stream is in a shallow v-shaped channel 1m wide by 0.4-0.5m deep. Peat bed with silt and medium-coarse rock. Peat banking with some exposed rock.</div></div> <div><div>CAR Category: Small</div><div>Catchment Area: 0.19 km² (upstream of crossing location)</div><div>Ecology: Migratory fish, unlikely. Mammals, none.</div><div>Crossing Type: Probably requiring upgrade of existing crossing: Circular culvert</div></div>

Looking across stream Viking KS01 across 1.jpg

Looking downstream Viking KS01 down.jpg

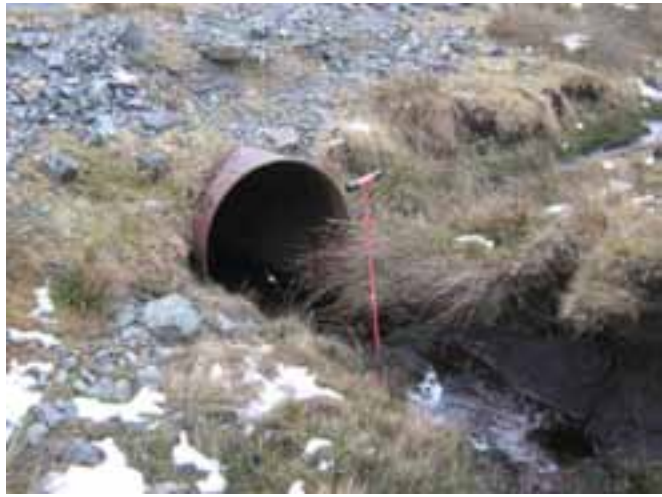
Looking upstream Viking KS01 up.jpg

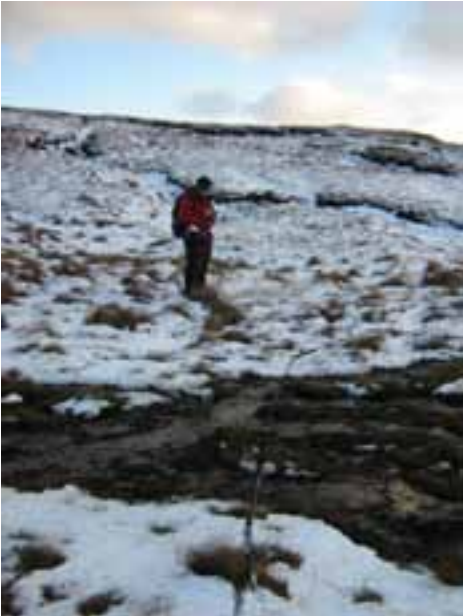
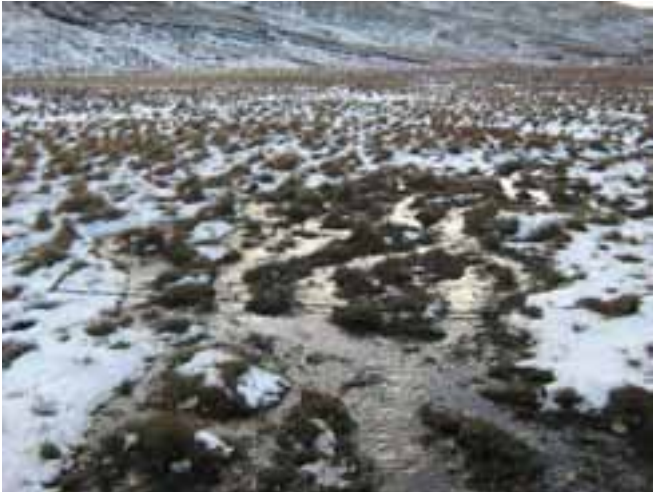
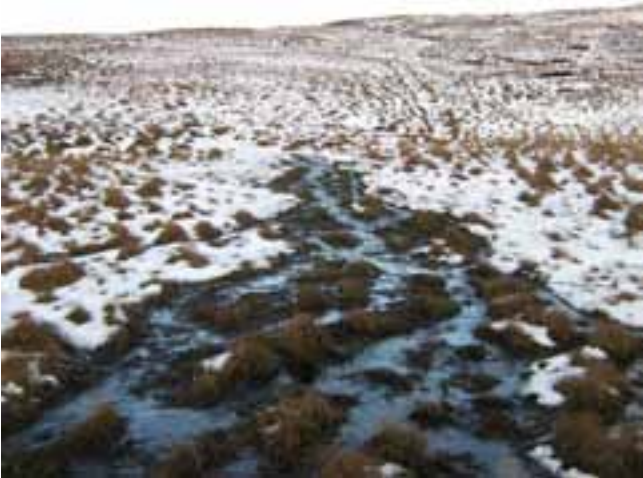
Viking Wind Farm Survey of Stream Crossings		
<div><div>Crossing: KS03</div><div>Route: Site Access Track between K50 & K51</div><div>Catchment ID: 2</div><div>Watercourse: Unnamed tributary of Red Burn</div><div>NGR: HU 38870 57849</div><div>Description: Poorly defined stream with diffuse flow. Flush over the surface up to 3m wide. Poor flow.</div><div>CAR Category: Medium</div><div>Catchment Area: 0.09 km² (upstream of crossing location)</div><div>Ecology: Migratory fish, none. Mammals, none.</div><div>Crossing Type: New crossing: Drainage layer and pipes</div></div>

Looking across stream Viking KS03 across 1.jpg	Looking downstream Viking KS03 down.jpg	Looking upstream Viking KS03 up.jpg

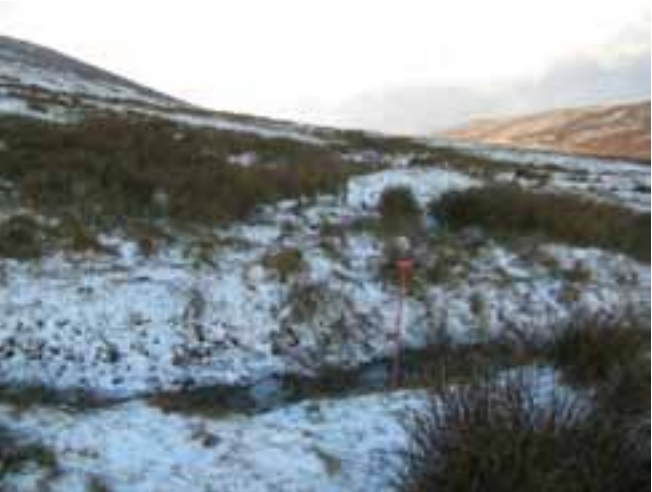
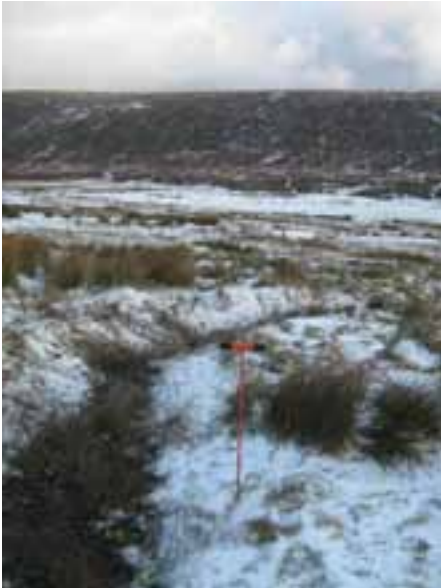
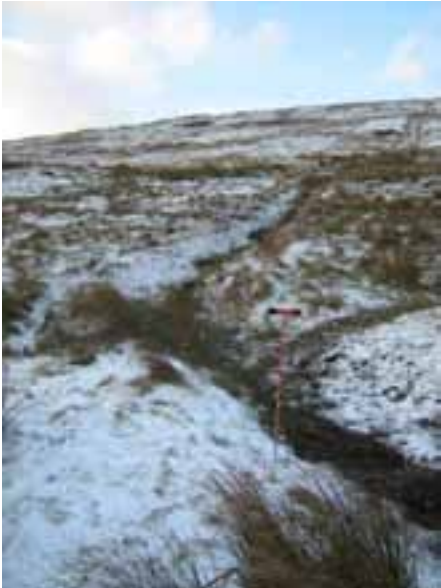
Viking Wind Farm Survey of Stream Crossings			
<p>Crossing: KS05</p> <p>Route: Access track to convertor station</p> <p>Catchment ID: 4</p> <p>Watercourse: Unnamed feeder burn to Burn of Weisdale</p> <p>NGR: HU 40027 56700</p> <p>Description: Small ditch, has been straightened and probably deepened. Channel 1.5m wide by 0.5m deep. Peat bed with some exposed rock and peat and vegetated banking. Note surveyed location was 100m W (upstream) of crossing position due to late layout amendment.</p> <p>CAR Category: Medium</p> <p>Catchment Area: 0.06 km² (upstream of crossing location)</p> <p>Ecology: Migratory fish, none. Mammals, none</p> <p>Crossing Type: New crossing: Circular culvert.</p>

<p>Looking across stream</p> <p>Viking KS05 across.jpg</p>		<p>Looking downstream</p> <p>Viking KS05 down.jp</p>

<p>Looking upstream</p> <p>Viking KS05 up.jpg</p>

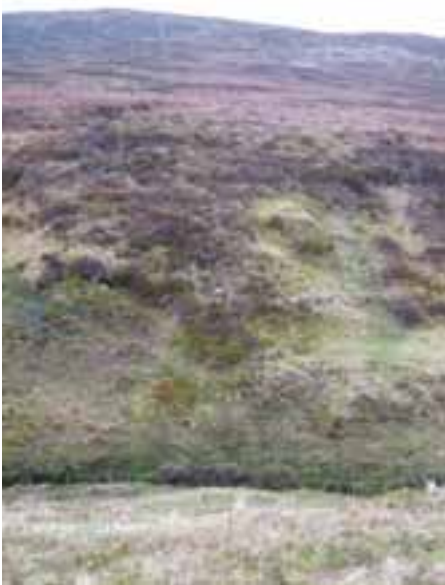
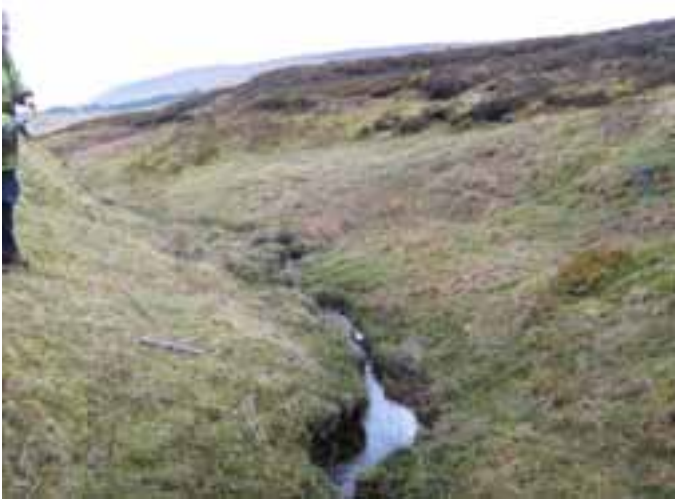
Viking Wind Farm Survey of Stream Crossings		
<div><div>Crossing: KS06</div><div>Route: Site access track between B9075 & K52</div><div>Catchment ID: 4</div><div>Watercourse: Burn of Droswall</div><div>NGR: HU 40013 55708</div><div>Description: Small Stream 0.1-0.2m wide, with a water depth of 0.1m. Channel 0.6m wide by 0.6m deep. Flood channel 14m wide by 5.5m high. Peat bed and vegetated peat banks.</div><div>CAR Category: Small</div><div>Catchment Area: 0.42 km² (upstream of crossing location)</div><div>Ecology: Migratory fish, none. Mammals, none</div><div>Crossing Type: New crossing: Rectangular culvert</div></div>	<div>

</div> <div>Looking across stream</div> <div>Viking KS06 across 2.jpg</div>	<div>

</div> <div>Looking downstream</div> <div>Viking KS06 down.jpg</div>	<div>

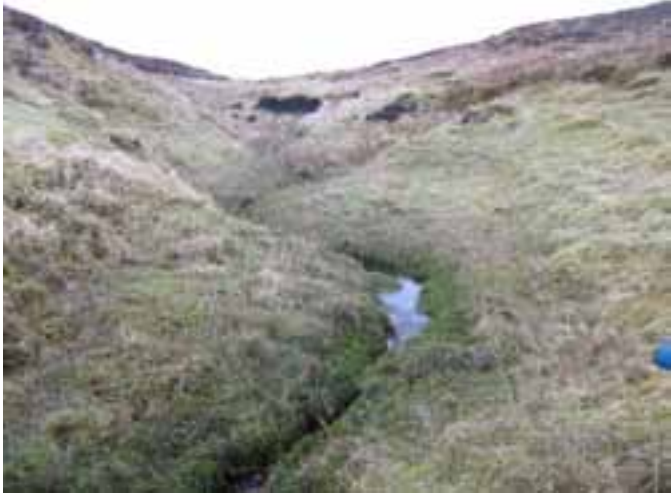
</div> <div>Looking upstream</div> <div>Viking KS06 up.jpg</div>

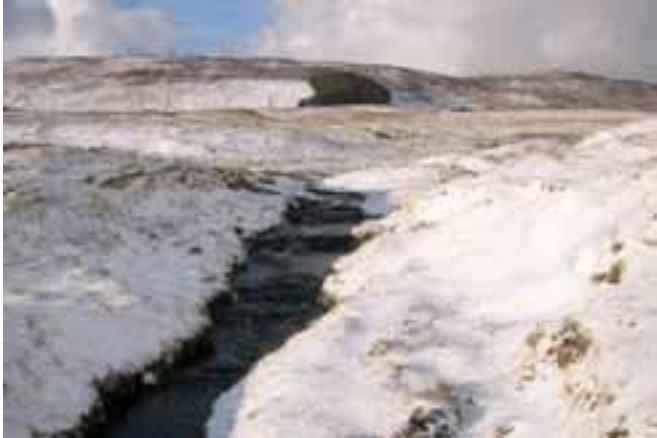
Viking Wind Farm Survey of Stream Crossings				
<p>Crossing: KS07 Route: Access track next to the B9075 Catchment ID: 4 Watercourse: Burn of Weisdale NGR: HU 40039 54862 Description: Small-Medium stream up to 1m wide in channel 0.5-2.0m wide by 0.5m deep, with a water depth of 0.2m. Peat bed and grass covered peat and mineral banks.</p> <p>CAR Category: Medium Catchment Area: 2.17 km² (upstream of crossing location) Ecology: Migratory fish, likely. Mammals, none Crossing Type: New crossing: Rectangular culvert</p>

Looking across stream	Viking KS07 across 2.jpg	Looking downstream	Viking KS07 down.jpg	Looking upstream
				Viking KS07 up.jpg

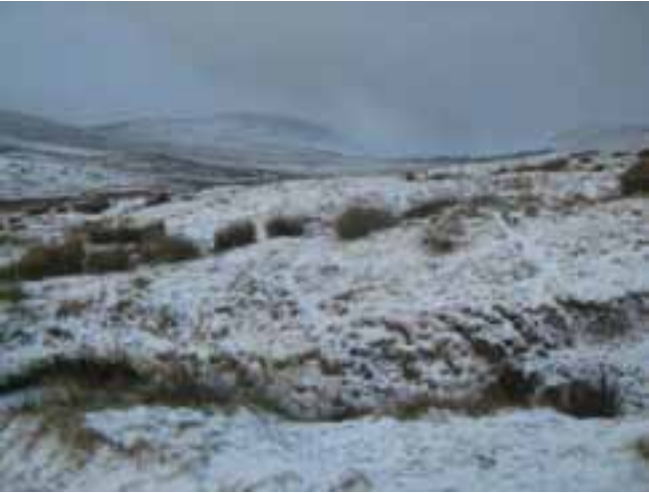
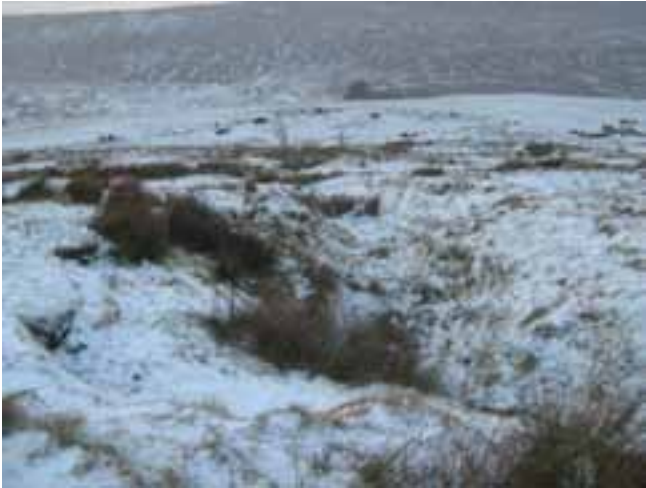
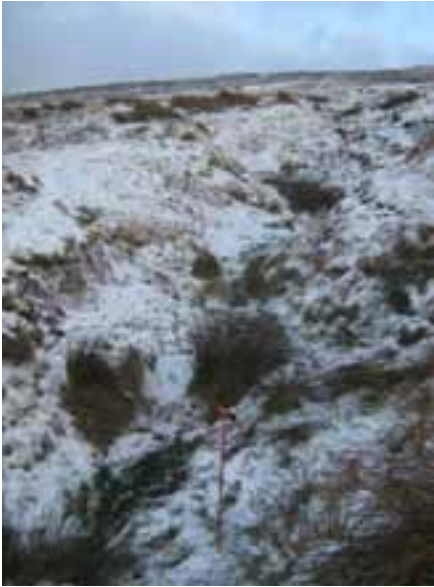
Viking Wind Farm Survey of Stream Crossings		
<div><div><div>Crossing: KS08</div><div>Route: Between K59 & K60</div><div>Catchment ID: 2</div><div>Watercourse: Unnamed inflow burn to Lamba Water</div><div>NGR: HU 38789 55638</div><div>Description: Small poorly defined channel up to 1m wide and 0.1-0.4m deep. Deep peat bed >1m. Channel is boggy with a water depth of 0.1m and is very overgrown with grass, moss and water vegetation.</div></div><div><div>CAR Category: Small</div><div>Catchment Area: 0.04 km² (upstream of crossing location)</div><div>Ecology: Migratory fish, none. Mammals, none</div><div>Crossing Type: New crossing: Circular culvert</div></div></div>	<div>

</div> <div>Looking across streamViking KS08 across 2.jpg</div>	<div>

</div> <div>Looking downstreamViking KS08 down.jpg</div>	<div>

</div> <div>Looking upstreamViking KS08 up.jpg</div>

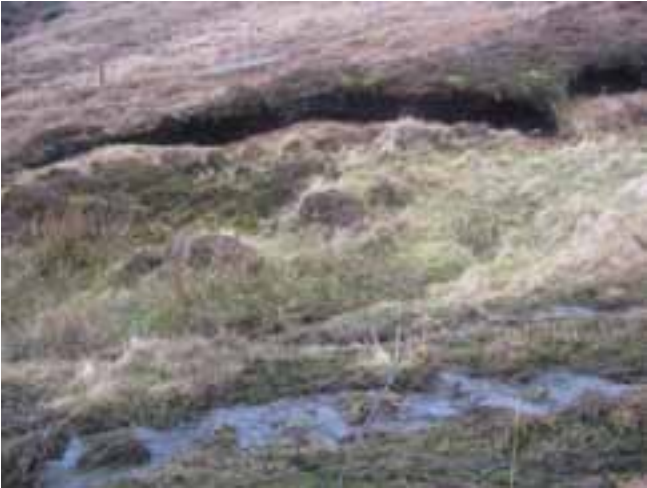
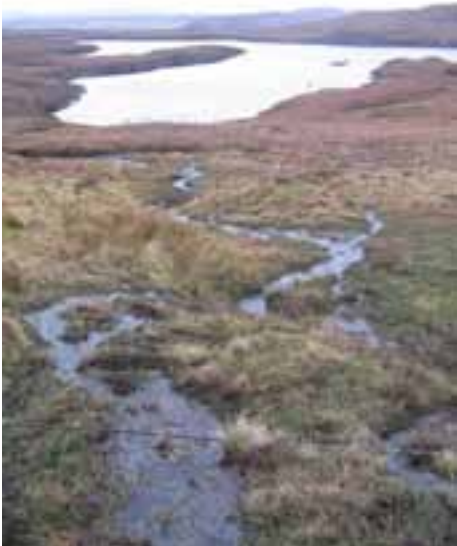
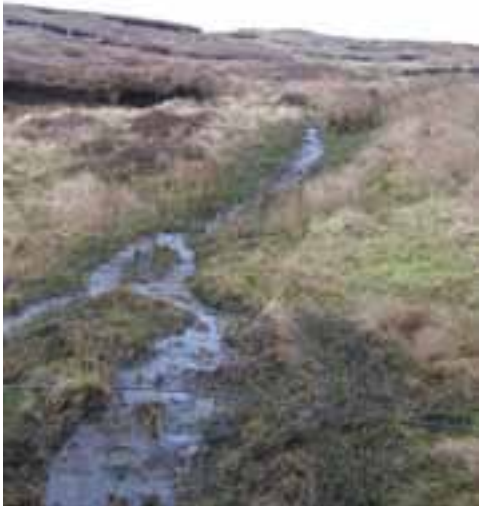
Viking Wind Farm Survey of Stream Crossings		
<div><div><div>Crossing: KS09</div><div>Route: Access track between K60 & K61</div><div>Catchment ID: 2</div><div>Watercourse: Unnamed inflow burn to Lamba Water</div><div>NGR: HU 38406 55428</div><div>Description: Poorly defined shallow channel up to 0.05m wide with a water depth of up to 0.01m. Vegetated bed.</div></div><div><div>CAR Category: Small</div><div>Catchment Area: 0.21 km² (upstream of crossing location)</div><div>Ecology: Migratory fish, none. Mammals, none</div><div>Crossing Type: New crossing: Multiple circular culverts</div></div></div>	<div>

</div> <div>Looking across stream</div> <div>Viking KS09 across 2.jpg</div>	<div>

</div> <div>Looking downstream</div> <div>Viking KS09 down.jpg</div>	<div>

</div> <div>Looking upstream</div> <div>Viking KS09 up.jpg</div>

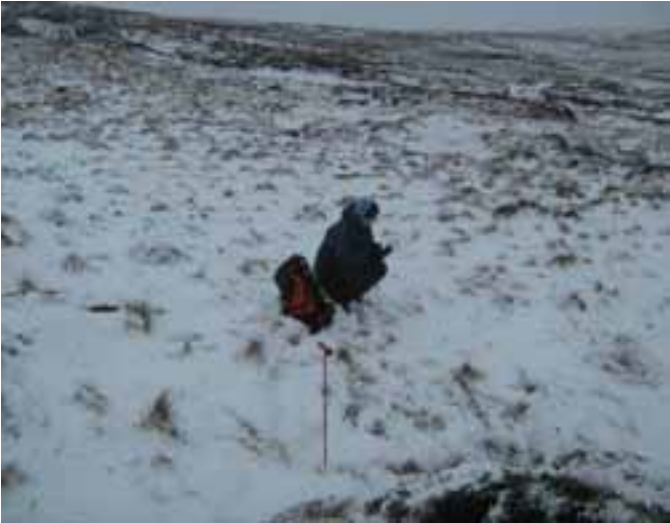
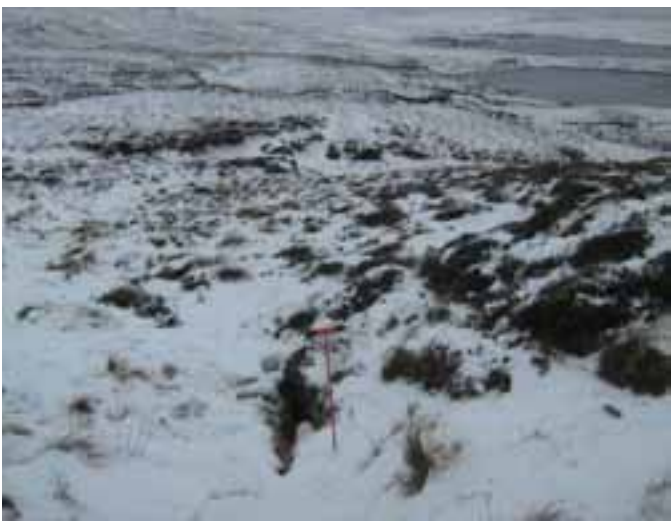
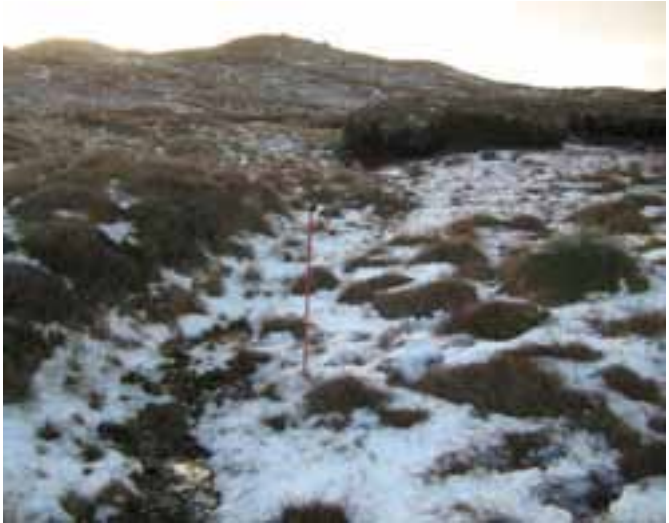
Viking Wind Farm Survey of Stream Crossings		
<div><div><div>Crossing: KS10</div><div>Route: Access track between K61 & K62</div><div>Catchment ID: 2</div><div>Watercourse: Unnamed inflow burn to Maa Water</div><div>NGR: HU 37839 50613</div><div>Description: Small stream up to 1m wide with 0.5-1m deep banking. Water 0.5m deep. No clear channel with peat bed and banking.</div></div><div><div>CAR Category: Small</div><div>Catchment Area: 0.14 km² (upstream of crossing location)</div><div>Ecology: Migratory fish, none. Mammals, none</div><div>Crossing Type: New crossing: Circular culvert</div></div></div>

Looking across stream Viking KS10 across 2.jpg	Looking downstream Viking KS10 down.jpg	Looking upstream Viking KS10 up.jpg

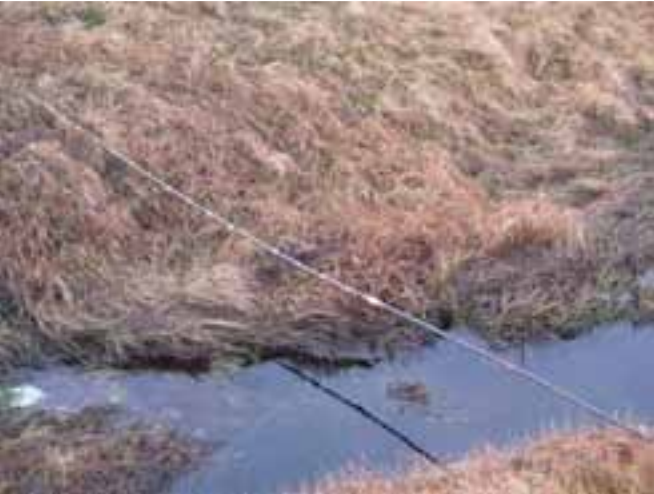
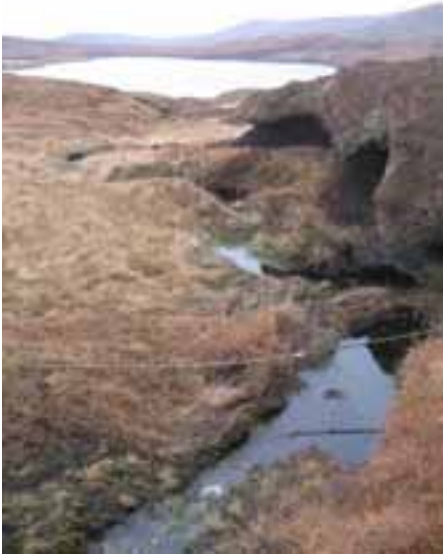
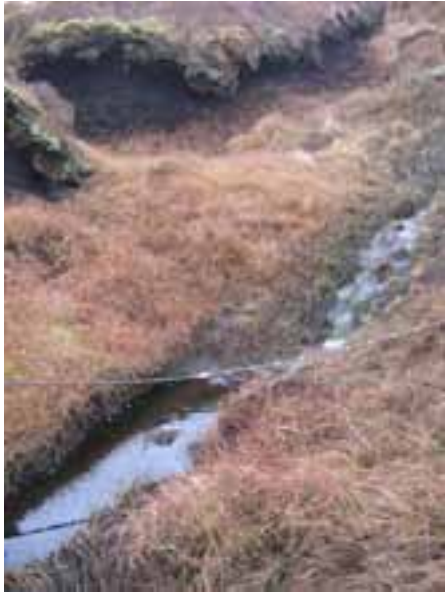
Viking Wind Farm Survey of Stream Crossings		
<div><div><div>Crossing: KS11</div><div>Route: Site access track between K62 and K63</div><div>Catchment ID: 2</div><div>Watercourse: Unnamed inflow burn to Maa Water</div><div>NGR: HU 37990 55428</div><div>Description: Small stream, water 0.2m deep. Defined channel 0.5-1.0m wide by 0.4m deep. Flood channel 12m wide by 1.2m high. Vegetated peat bed with some exposed coarse rock.</div></div><div><div>CAR Category: Small</div><div>Catchment Area: 0.14 km² (upstream of crossing location)</div><div>Ecology: Migratory fish, none. Mammals, none</div><div>Crossing Type: New crossing: Circular culvert</div></div></div>	<div>

</div> <div>Looking across stream</div> <div>Viking KS11 across 2.jpg</div>	<div>

</div> <div>Looking downstream</div> <div>Viking KS11 down.jpg</div>	<div>

</div> <div>Looking upstream</div> <div>Viking KS11 up.jpg</div>

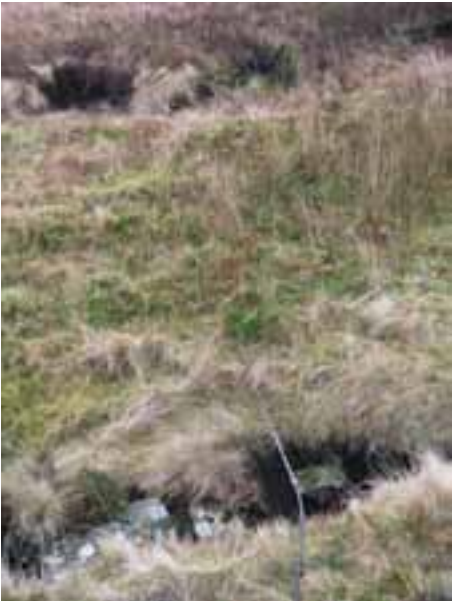
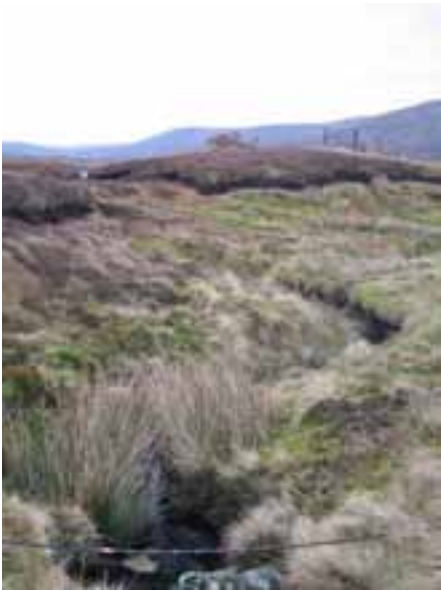
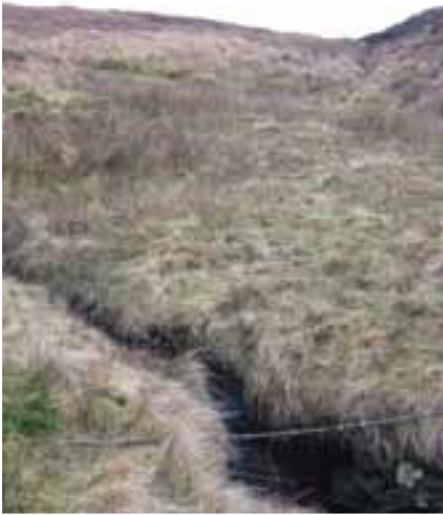
Viking Wind Farm Survey of Stream Crossings		
<div><div><div>Crossing: KS12</div><div>Route: Site access track between K62 & K63</div><div>Catchment ID: 2</div><div>Watercourse: Unnamed inflow burn to Maa Water</div><div>NGR: HU 37945 54611</div><div>Description: Well defined channel 0.5m wide but up to 1.1m wide in places by 0.5-1m deep. Water depth 0.3m. Flood channel 4.5m wide & 3m high. Coarse rock and peat bed with vegetated peat banks.</div></div><div><div>CAR Category: Small</div><div>Catchment Area: 0.23 km² (upstream of crossing location)</div><div>Ecology: Migratory fish, none. Mammals, none</div><div>Crossing Type: New crossing: Circular culvert.</div></div></div>

Looking across stream Viking KS12 across 2.jpg	Looking downstream Viking KS12 down.jpg	Looking upstream Viking KS12 up.jpg

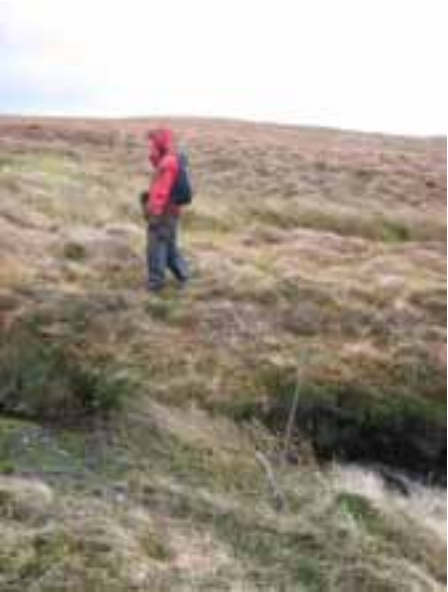
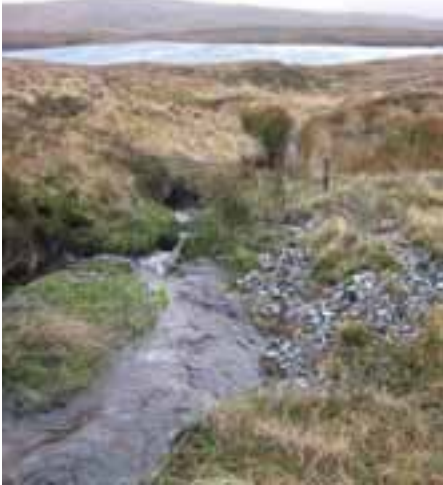
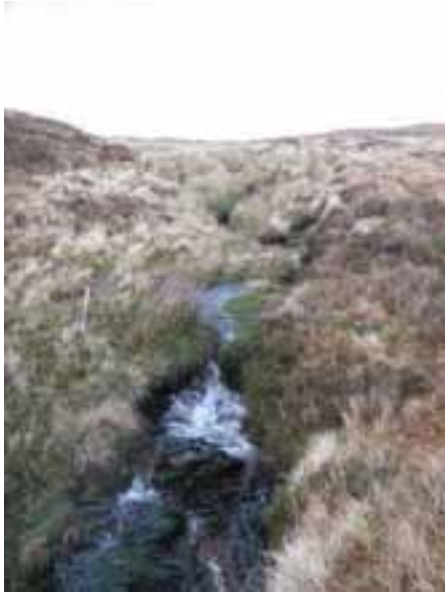
Viking Wind Farm Survey of Stream Crossings		
<div><div>Crossing: KS13</div><div>Route: Between K63 & K64</div><div>Catchment ID: 2</div><div>Watercourse: Unnamed inflow burn to Truggles Water</div><div>NGR: HU 37463 54387</div><div>Description: Small to medium stream in V- shaped channel 0.5-1.1m wide by 0.5m deep, with a water depth of 0.2m. Predominantly cobbles and pebbles on stream bed and grass covered peat and mineral banks.</div><div>CAR Category: Medium</div><div>Catchment Area: 0.36 km² (upstream of crossing location)</div><div>Ecology: Migratory fish, likely. Mammals, none</div><div>Crossing Type: New crossing: Rectangular culvert</div></div>

<p>Looking across stream</p> <p>Viking KS13 across 2.jpg</p>

<p>Looking downstream</p> <p>Viking KS13 down.jpg</p>

<p>Looking upstream</p> <p>Viking KS13 up.jpg</p>

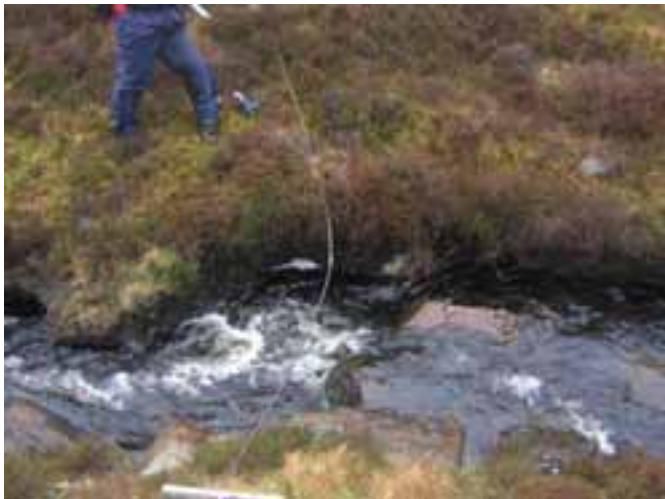
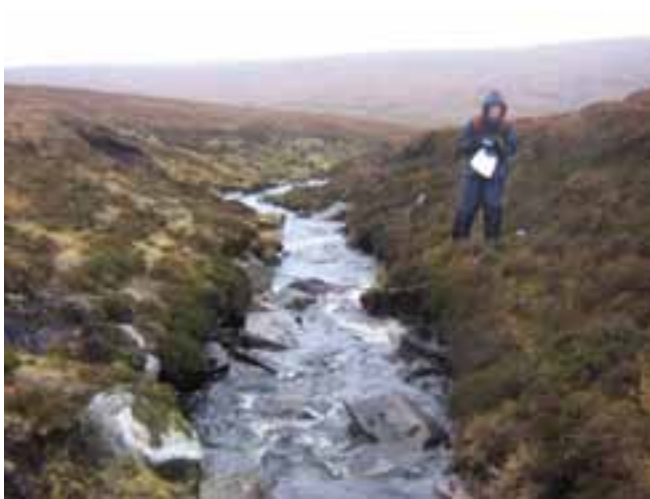
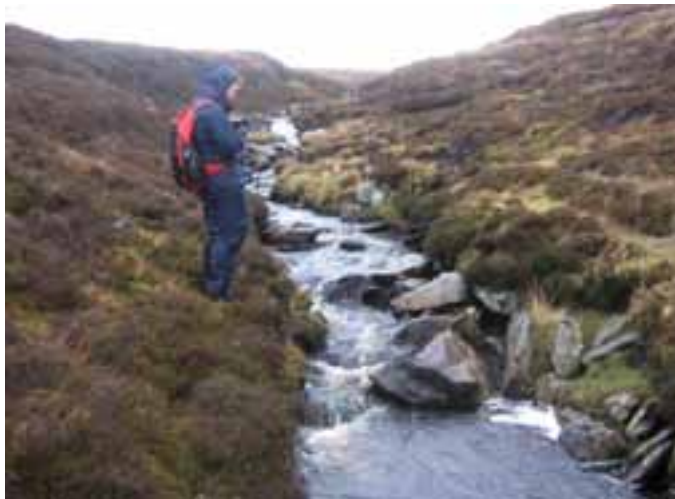
Viking KS14 across 2.jpg	Viking KS14 down.jpg	Viking KS14 up.jpg

Viking Wind Farm Survey of Stream Crossings		
<div><div><div>Crossing:</div><div>Route:</div><div>Catchment ID:</div><div>Watercourse:</div><div>NGR:</div><div>Description:</div><div>CAR Category:</div><div>Catchment Area:</div><div>Ecology:</div><div>Crossing Type:</div></div><div><div>KS14</div><div>Between K65 & K66</div><div>2</div><div>Outflow burn from Truggles Water</div><div>HU 36844 54434</div><div>Medium stream with good flow in well defined channel 1.5-2m wide by 0.8m deep, with a water depth of 0.2m. Predominantly boulders on stream bed and vegetated, peat and mineral banks. V shaped flood channel</div><div>Medium</div><div>2.73 km² (upstream of crossing location)</div><div>Migratory fish, present. Mammals, none</div><div>New crossing: Rectangular culvert / arch</div></div></div>

Looking across stream	Looking downstream	Looking upstream
