Viking Wind Farm

Technical Appendix 14.3 Stream Crossing Guidance

February 2009

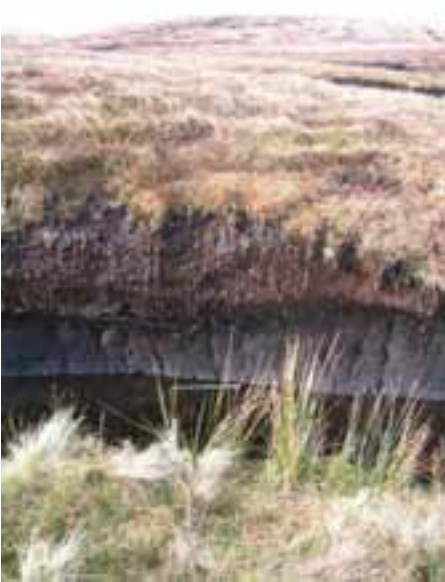
Viking Wind Farm Survey of Stream Crossings		
<div><div><div>Crossing: KS15</div><div>Route: Between K74 & K76</div><div>Catchment ID: 2</div><div>Watercourse: Burn of Atlascord</div><div>NGR: HU 37888 53278</div><div>Description: Medium stream in well-defined channel 1m wide by 1.5m deep, with a water depth of 0.2m. Peat with fine silt/sand and gravel/pebble bed. Steep peat banks.</div></div><div><div>CAR Category: Medium</div><div>Catchment Area: 0.23 km² (upstream of crossing location)</div><div>Ecology: Migratory fish, none. Mammals, none</div><div>Crossing Type: New crossing: Rectangular culvert</div></div></div>

<p>Looking across stream</p> <p>Viking KS15 across 2.jpg</p>

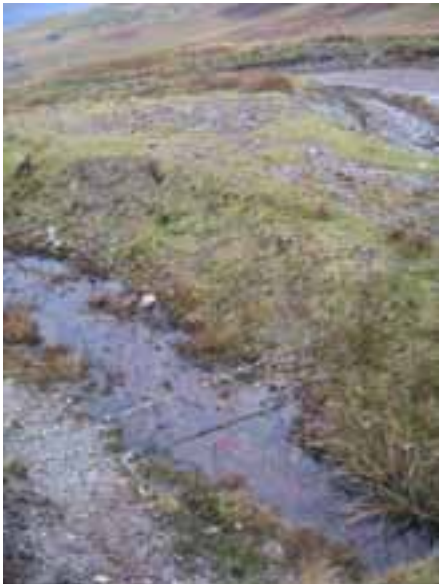
<p>Looking across stream</p> <p>Viking KS16 across 2.jpg</p>

Viking Wind Farm Survey of Stream Crossings		
<div><div><div>Crossing:</div><div>Route:</div><div>Catchment ID:</div><div>Watercourse:</div><div>NGR:</div><div>Description:</div><div>CAR Category:</div><div>Catchment Area:</div><div>Ecology:</div><div>Crossing Type:</div></div><div><div>KS16</div><div>Site access track south of K76</div><div>30</div><div>Unnamed feeder burn to Weisdale Voe</div><div>HU 37839 50613</div><div>Small/medium stream in well-defined channel 0.9 -1.2m wide by 0.7 m deep and a water depth of 0.05m. Fine silt/sand and gravel/pebble bed. Burn culverted under existing road.</div><div>Medium</div><div>0.03 km² (upstream of crossing location)</div><div>Migratory fish, unlikely. Mammals, none</div><div>Existing crossing: Possible upgrade with circular culvert</div></div></div>

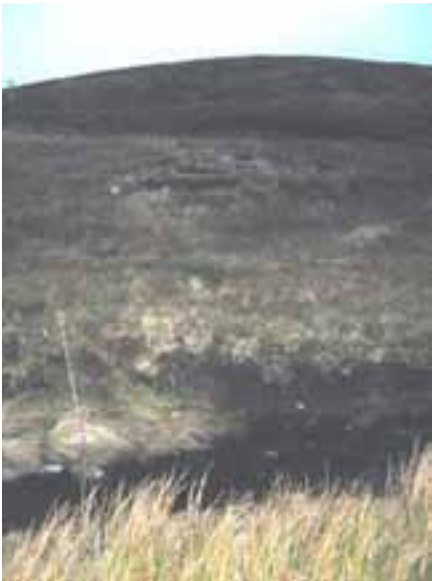
<p>Looking across stream</p> <p>Viking NS01 across 1.jpg</p>

Viking Wind Farm Survey of Stream Crossings		
<div><div><div>Crossing: NS01</div><div>Route: Between A970 & N89</div><div>Catchment ID: 11</div><div>Watercourse: Tributary channel of Wester Filla Burn</div><div>NGR: HU 41389 60808</div><div>Description: Medium stream in defined channel 0.9-1.5m wide by 0.4m deep. Water depth 0.2m. Flood channel 2m wide and up to 2.7m high. Coarse rock bed and mineral banking overlain by peat.</div></div><div><div>CAR Category: Medium</div><div>Catchment Area: 0.44 km² (upstream of crossing location)</div><div>Ecology: Migratory fish, present. Mammals, none</div><div>Crossing Type: New crossing: Rectangular culvert</div></div></div>

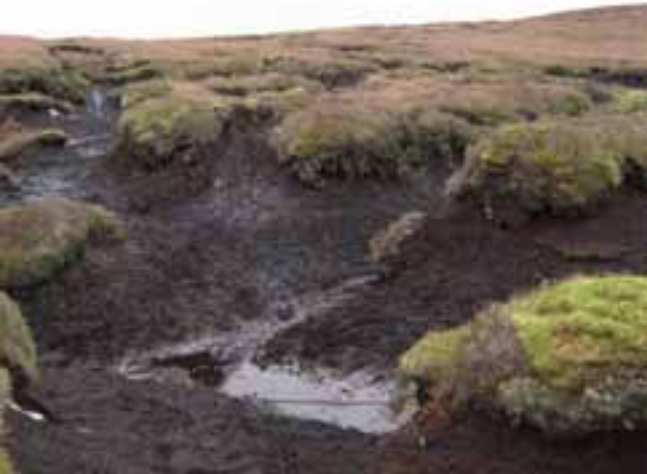
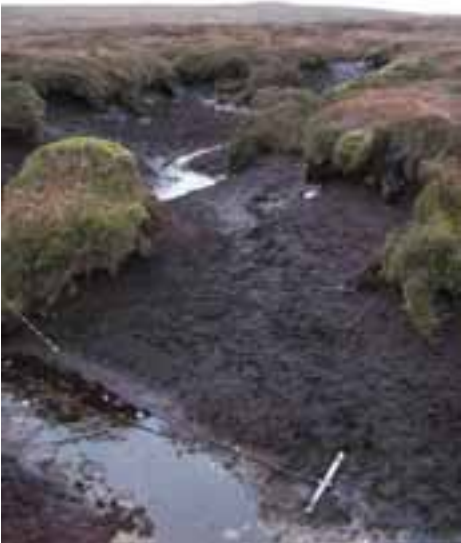
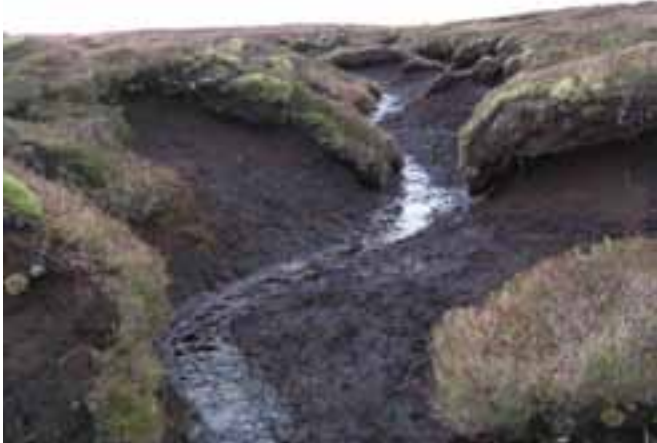
Looking across stream Viking NS02 across 1.jpg	Looking downstream Viking NS02 down.jpg	Looking upstream Viking NS02 up.jpg

Viking Wind Farm Survey of Stream Crossings		
<div><div>Crossing: NS02</div><div>Route: Between N89 & N90</div><div>Catchment ID: 11</div><div>Watercourse: Tributary burn to Wester Filla Burn</div><div>NGR: HU 41912 60877</div><div>Description: Small stream 0.6-0.9m in peat channel 4.5m wide by 1.6m deep. Water 0.02m deep with very little flow. Peaty bed with silt and gravel deposits.</div><div>CAR Category: Small</div><div>Catchment Area: 0.04 km² (upstream of crossing location)</div><div>Ecology: Migratory fish, none. Mammals, none</div><div>Crossing Type: New crossing: Multiple circular culverts</div></div>

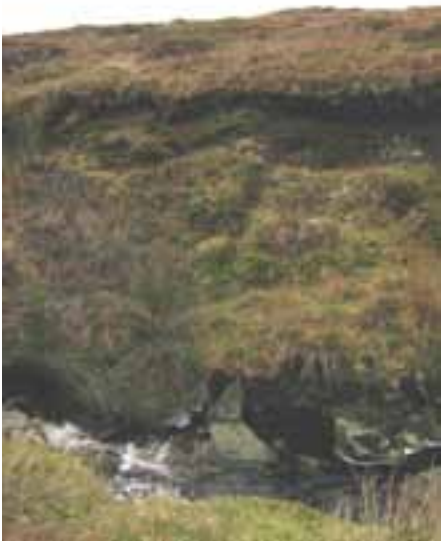
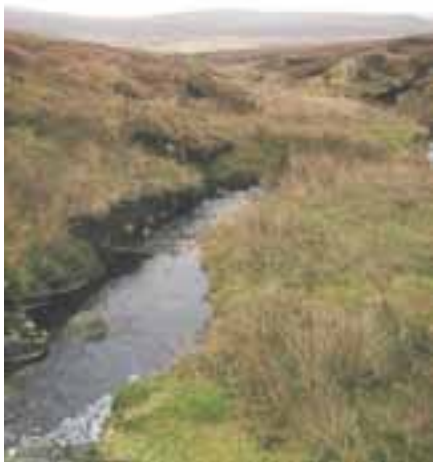
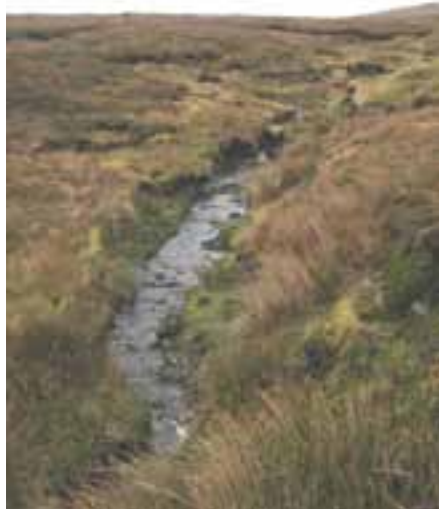
Looking across stream Viking NS03 across 1.jpg	Looking downstream Viking NS03 down.jpg	Looking upstream Viking NS03 up.jpg

Viking Wind Farm Survey of Stream Crossings		
<div><div><div>Crossing: NS03</div><div>Route: Between N90 & N92</div><div>Catchment ID: 1</div><div>Watercourse: Easter Filla Burn</div><div>NGR: HU 42394 61503</div><div>Description: Small/medium stream in well defined channel 1-2 wide and 0.6-1m high. Water depth 0.2m. Bed of predominantly cobbles & coarse bare rock. Vegetated peat banking.</div></div><div><div>CAR Category: Medium</div><div>Catchment Area: 0.59 km² (upstream of crossing location)</div><div>Ecology: Migratory fish, likely. Mammals, none</div><div>Crossing Type: New crossing: Rectangular culvert / arch</div></div></div>

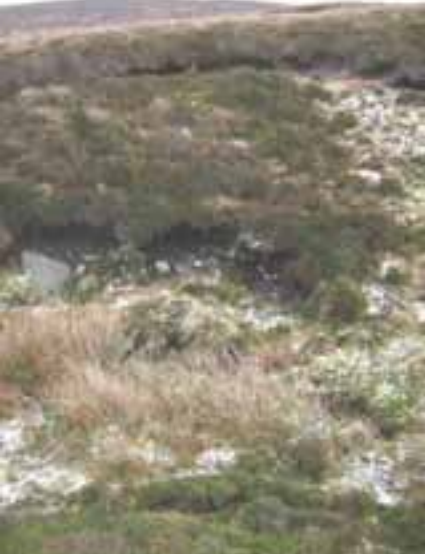
</div> <div>Looking across stream</div> <div>Viking NS04 across 1.jpg</div>	<div>

Viking Wind Farm Survey of Stream Crossings		
<div><div><div>Crossing:</div><div>Route:</div><div>Catchment ID:</div><div>Watercourse:</div><div>NGR:</div><div>Description:</div><div>CAR Category:</div><div>Catchment Area:</div><div>Ecology:</div><div>Crossing Type:</div></div><div><div>NS04</div><div>Between N93 & N95</div><div>1</div><div>Unnamed feeder burn to Laxo Burn</div><div>HU 42983 62299</div><div>Small stream in well defined channel. Channel 0.6-1m wide by 0.6m deep. Water depth 0.2m. V-shaped flood channel 5.5m wide by 3m deep. Peat bed with some coarse rock bed. Mineral and peat banking.</div><div>Small</div><div>0.47 km² (upstream of crossing location)</div><div>Migratory fish, likely. Mammals, likely.</div><div>New crossing: Rectangular culvert /arch with mammal passage.</div></div></div>	<div>

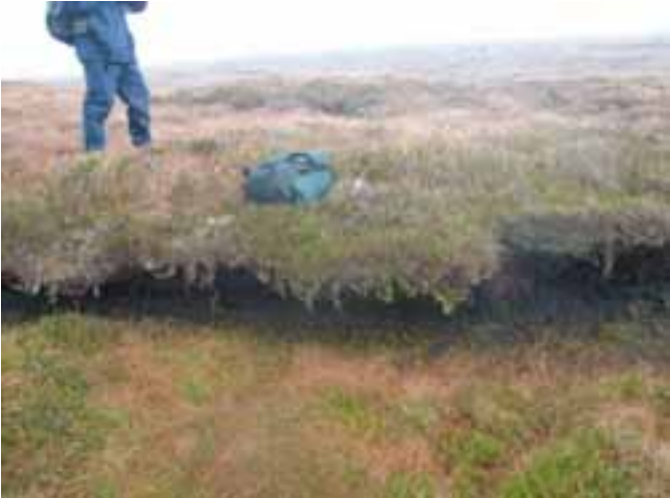
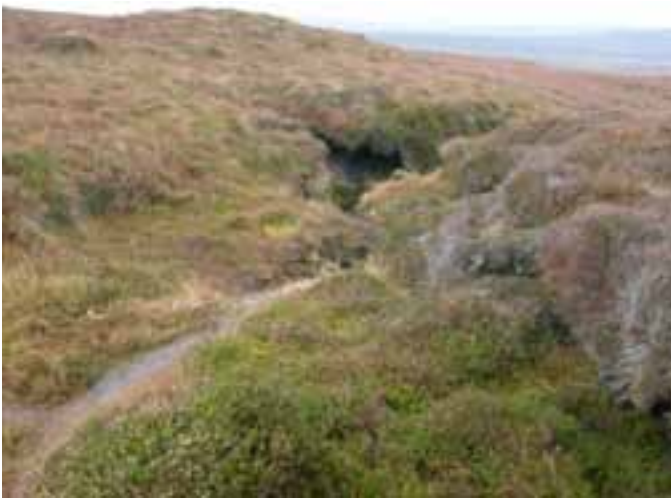
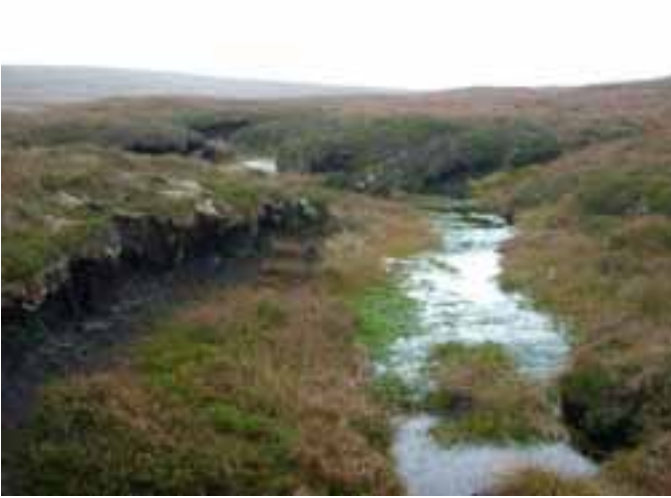
Looking across stream Viking NS05 across 2.jpg	Looking downstream Viking NS05 down.jpg	Looking upstream Viking NS05 up.jpg

Viking Wind Farm Survey of Stream Crossings		
<div><div>Crossing: NS05</div><div>Route: Between N95 & N96</div><div>Catchment ID: 1</div><div>Catchment ID: Unnamed tributary to Gossawater</div><div>Watercourse: HU 43711 62305</div><div>NGR: Small/medium 0.5-1.5m wide stream in flood channel up to 5.5m wide and 1.5m high. Water depth 0.05m. Peat and vegetated peat banks.</div><div>Description:</div></div> <div><div>CAR Category: Medium</div><div>Catchment Area: 0.41 km² (upstream of crossing location)</div><div>Ecology: Migratory fish, none. Mammals, none</div><div>Crossing Type: New crossing: Circular culvert</div></div>

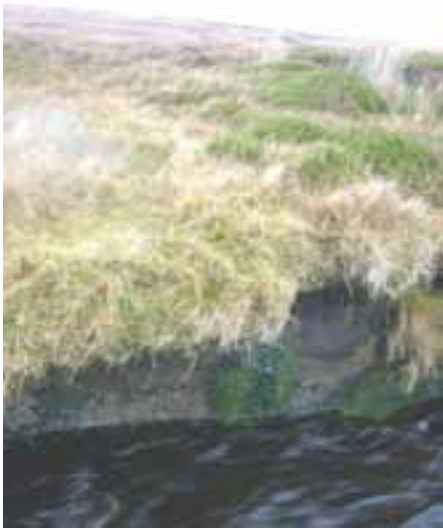
</div> <div>Looking across stream</div> <div>Viking NS06 across 1.jpg</div>	<div>

Viking Wind Farm Survey of Stream Crossings		
<div><div><div>Crossing:</div><div>Route:</div><div>Catchment ID:</div><div>Watercourse:</div><div>NGR:</div><div>Description:</div><div>CAR Category:</div><div>Catchment Area:</div><div>Ecology:</div><div>Crossing Type:</div></div><div><div>NS06</div><div>Between N95 & N96</div><div>1</div><div>Gossawater Burn feeding to Laxo Burn</div><div>HU 43775 62316</div><div>Incised medium burn in well-defined channel 3m wide and up to 2.5m high, water 0.2m deep. Stony bed of predominantly cobbles and boulders, peat banking.</div><div>Large</div><div>5.65 km² (upstream of crossing location)</div><div>Migratory fish, present. Mammals, present</div><div>New crossing: Bridge</div></div></div>	<div>

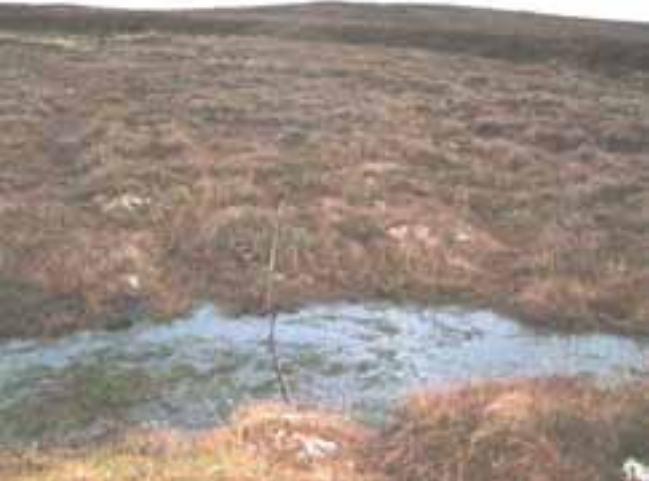
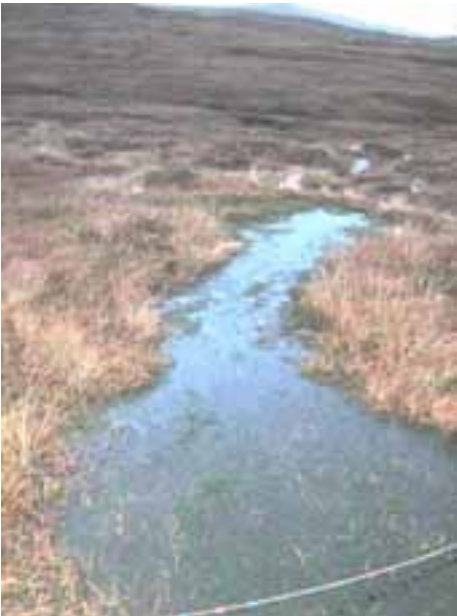
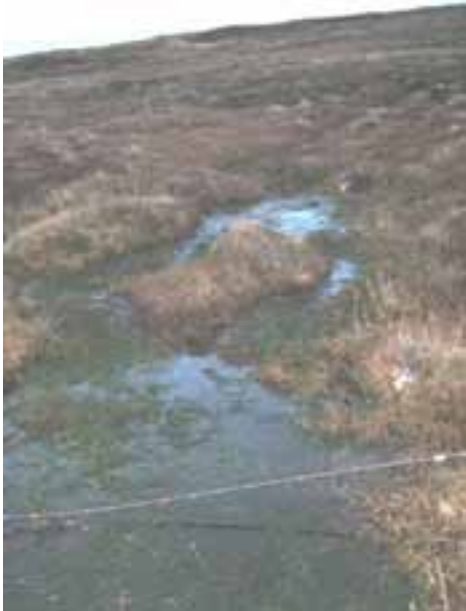
Looking across stream Viking NS07 across 2.jpg	Looking downstream Viking NS07 down.jpg	Looking upstream Viking NS07 up.jpg

Viking Wind Farm Survey of Stream Crossings		
<div><div><div>Crossing: NS07</div><div>Route: Between N96 & N97</div><div>Catchment ID: 1</div><div>Watercourse: Unnamed feeder burn to Gossawater burn</div><div>NGR: HU 43921 62142</div><div>Description: Very shallow stream in shallow channel 1-2m wide by 0.2m deep. Almost no flow, area around stream very boggy. Vegetated peat bed and banks.</div></div><div><div>CAR Category: Medium</div><div>Catchment Area: 0.07 km² (upstream of crossing location)</div><div>Ecology: Migratory fish, none. Mammals, unlikely</div><div>Crossing Type: New crossing: Drainage layer and pipes</div></div></div>

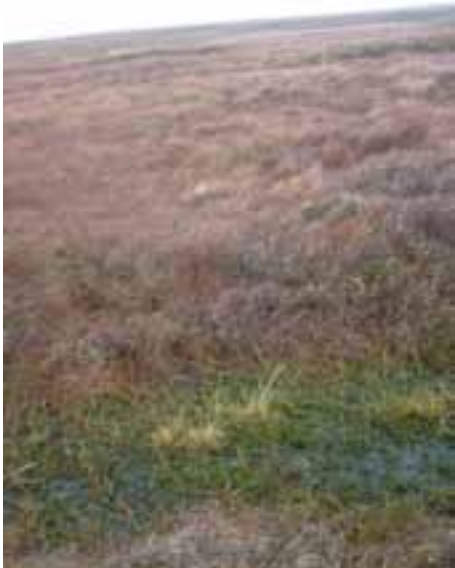
<div>Looking across stream</div> <div>Viking NS08 across 2.jpg</div>

Viking Wind Farm Survey of Stream Crossings		
<div><div>Crossing: NS08</div><div>Route: Between N96 & N97</div><div>Catchment ID: 1</div><div>Watercourse: Unnamed feeder burn to Gossawater Burn</div><div>NGR: HU 43885 61810</div><div>Description: Poorly defined stream, flush in places. Channel up to 1.5m wide and up to 0.5m deep. Water 0.05m deep with very little flow. Peat and vegetated bed.</div><div>CAR Category: Medium</div><div>Catchment Area: 0.23 km² (upstream of crossing location)</div><div>Ecology: Migratory fish, none. Mammals, none</div><div>Crossing Type: New crossing: Drainage layer and pipes.</div></div>

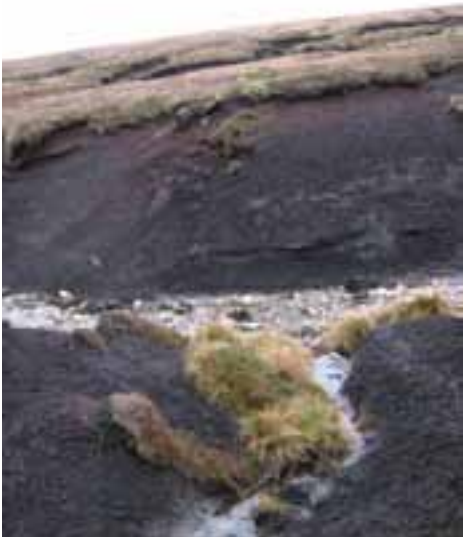
Looking across stream Viking NS09 across.jpg

Viking Wind Farm Survey of Stream Crossings	
<div><div>Crossing: NS09</div><div>Route: Between N100, N101 & N102</div><div>Catchment ID: 1</div><div>Watercourse: Easter Filla Burn</div><div>NGR: HU 42231 60457</div><div>Description: Broad medium burn in well-defined peat channel 2-4m wide and up to 4m high, water 0.2m deep. Flood channel up to 5m wide. Stony bed with peat banks.</div><div>CAR Category: Medium</div><div>Catchment Area: 0.05 km² (upstream of crossing location)</div><div>Ecology: Migratory fish, none. Mammals, none</div><div>Crossing Type: New crossing: Multiple circular culverts</div></div>

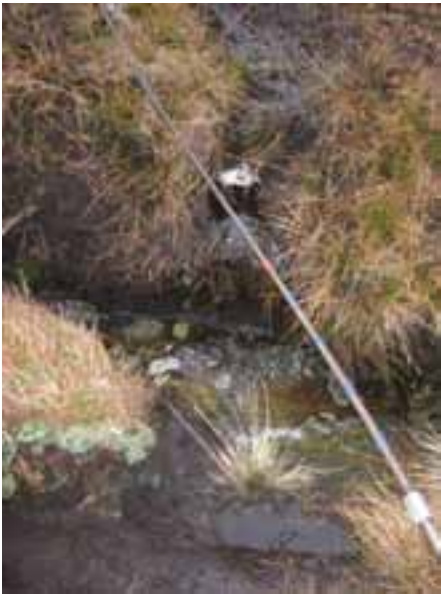
<div>Looking across stream</div> <div>Viking NS10 across 1.jpg</div>

Viking Wind Farm Survey of Stream Crossings		
<div><div><div>Crossing: NS10</div><div>Route: Between N126 & N127</div><div>Catchment ID: 6</div><div>Watercourse: Unnamed inflow burn to Quinni Loch</div><div>NGR: HU 44517 59127</div><div>Description: Small stream up to 0.5m wide by 2m deep, with a water depth of 0.05m. Flood channel 8m wide by 4m high. Medium sized stone bed and grass covered peat banks.</div></div><div><div>CAR Category: Small</div><div>Catchment Area: 0.15 km² (upstream of crossing location)</div><div>Ecology: Migratory fish, none. Mammals, none</div><div>Crossing Type: New crossing: Rectangular culvert</div></div></div>

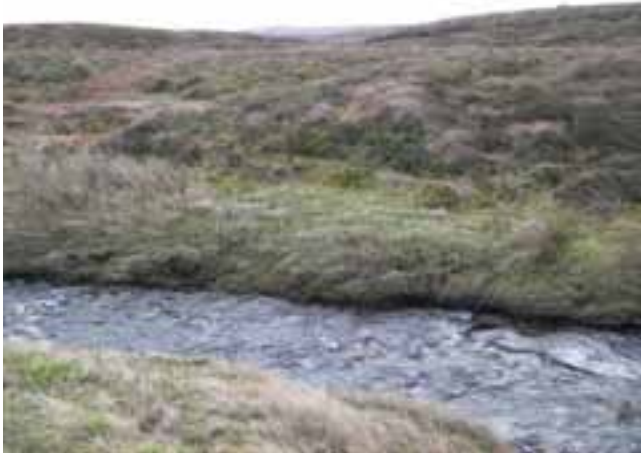
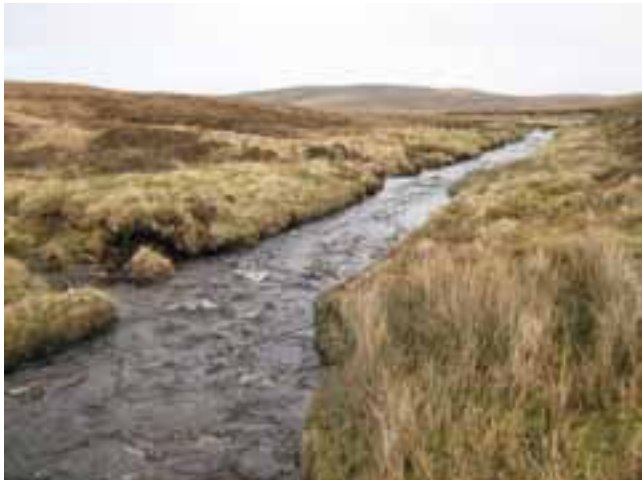
Looking across stream	Viking NS11 across 2.jpg	Looking downstream	Viking NS11 down.jpg

Viking Wind Farm Survey of Stream Crossings			
<div><div>Crossing: NS11</div><div>Route: Site access track between N140 and N141</div><div>Catchment ID: 6</div><div>Watercourse: Burn of Grunnafirth</div><div>NGR: HU 45542 58690</div><div>Description: Large well defined channel. Good fast flow. Channel 3m wide and 1m deep. Water depth 0.5m. Large rocks on bed</div><div>CAR Category: Large</div><div>Catchment Area: 5.89 km² (upstream of crossing location)</div><div>Ecology: Migratory fish, present. Mammals, likely</div><div>Crossing Type: New crossing: Bridge</div></div>	<div>

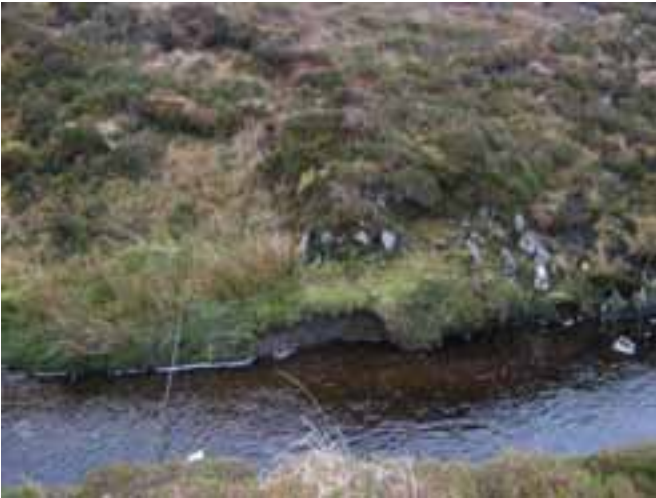
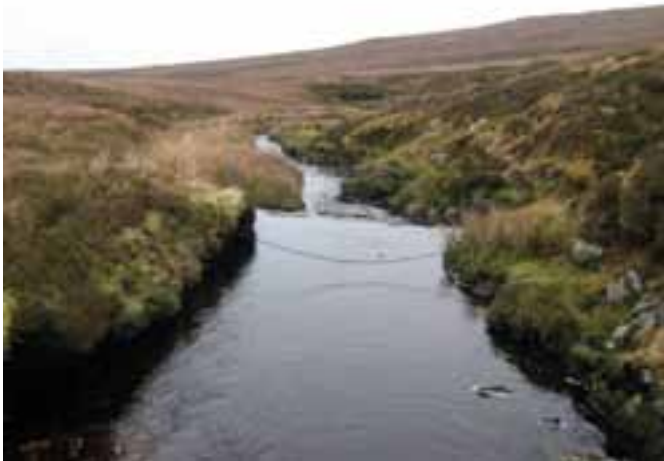
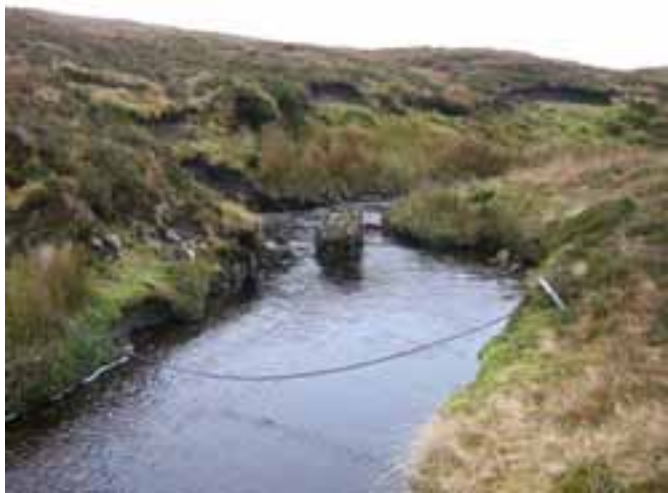
Viking NS12 across 1.jpg	Viking NS12 down.jpg	Viking NS12 up.jpg

Looking across stream	Looking downstream	Looking upstream

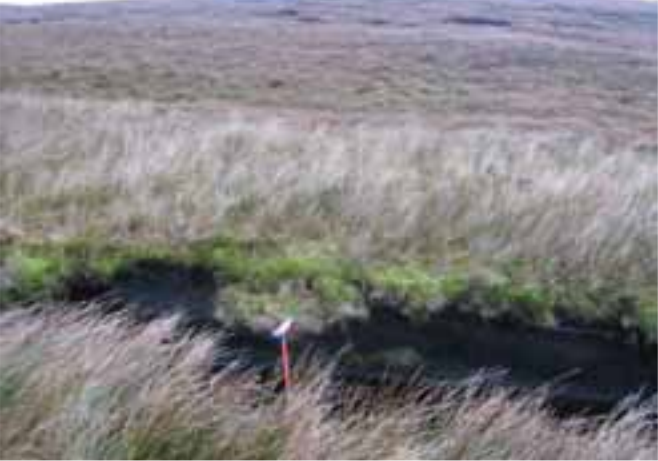
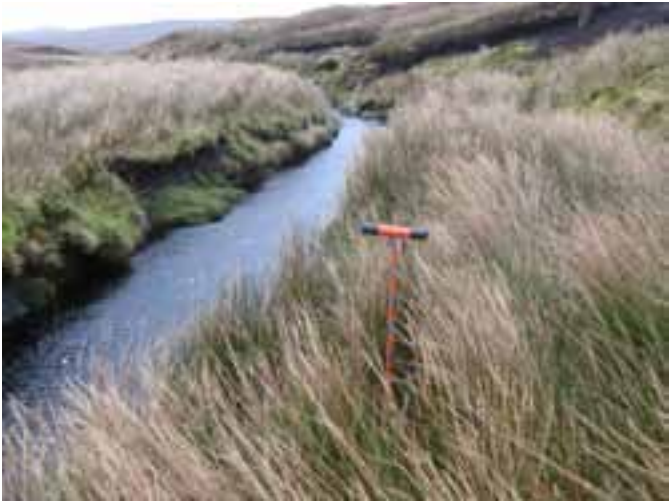
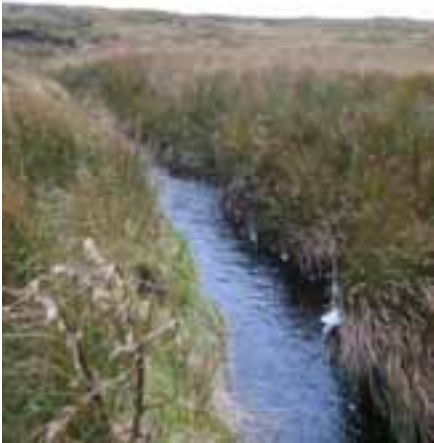
Viking Wind Farm Survey of Stream Crossings		
<div><div><div>Crossing: NS13</div><div>Route: Between N120 & N122</div><div>Catchment ID: 6</div><div>Watercourse: Burn of Forse</div><div>NGR: HU 43755 58013</div><div>Description: Medium stream in channel 2-3m wide and 1-2m deep. Predominantly boulder, cobble and pebble bed. Water level 0.4m. Peat banking.</div></div><div><div>CAR Category: Medium</div><div>Catchment Area: 2.41 km² (upstream of crossing location)</div><div>Ecology: Migratory fish, present. Mammals, possible</div><div>Crossing Type: New crossing: Rectangular culvert / arch with mammal passage.</div></div></div>

<p>Looking across stream</p> <p>Viking NS13 across 1.jpg</p>

<p>Looking downstream</p> <p>Viking NS13 down.jpg</p>

<p>Looking upstream</p> <p>Viking NS13 up.jpg</p>

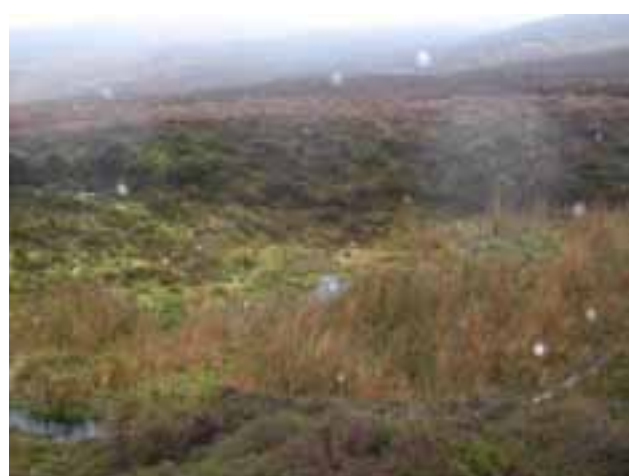
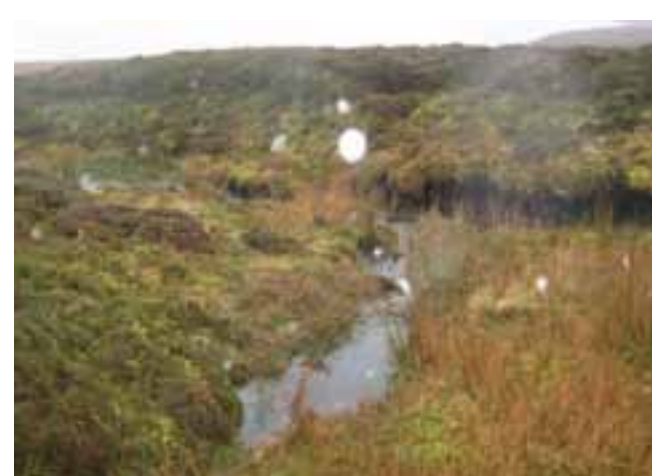
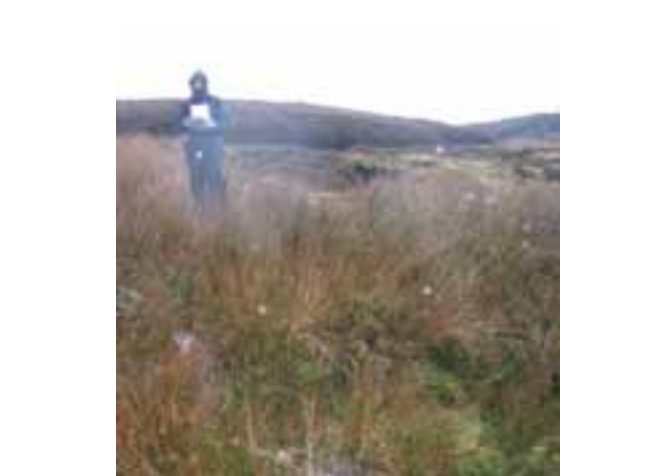
Viking NS14 across 1.jpg		Viking NS14 down.jpg	
Viking NS14 up.jpg

Viking Wind Farm Survey of Stream Crossings			
<p>Crossing: NS14</p> <p>Route: Track between B9075 and N150</p> <p>Catchment ID: 24</p> <p>Watercourse: Unnamed inflow burn into Loch of Skellister</p> <p>NGR: HU 46075 56627</p> <p>Description: Peat pipe with some overground flow. Channel 1m wide by 0.15m deep. Flood channel 11m wide by around 2.3m high. Vegetated peat bed and banking.</p> <p>CAR Category: Medium</p> <p>Catchment Area: 0.14 km² (upstream of crossing location)</p> <p>Ecology: Migratory fish, none. Mammals, none</p> <p>Crossing Type: New crossing: Circular culvert</p>

Looking across stream

Looking downstream

Looking upstream

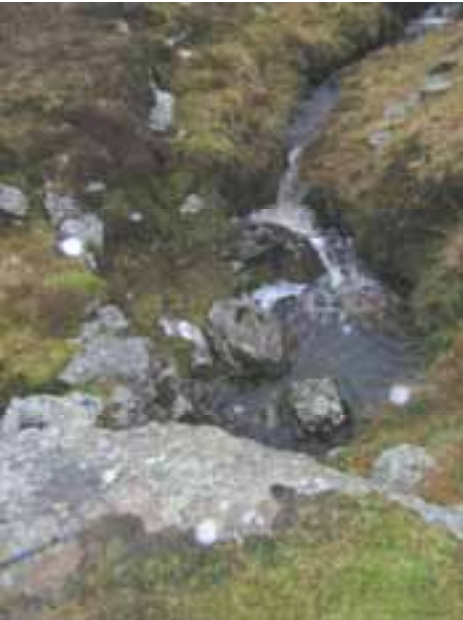
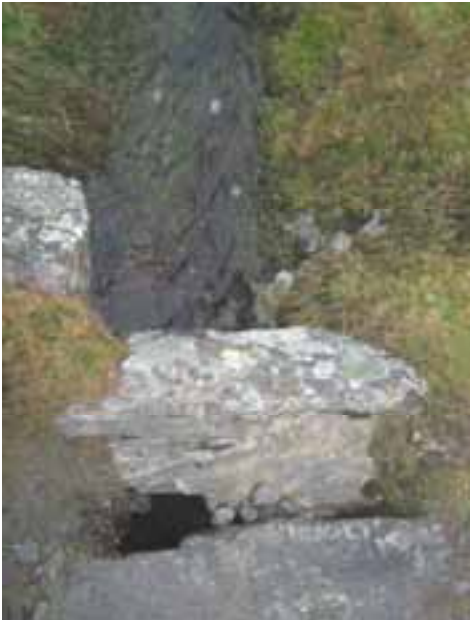
Viking Wind Farm Survey of Stream Crossings				
<p>Crossing: NS15 Route: Site access track between B9075 and N150 Catchment ID: 24 Watercourse: Unnamed inflow burn into Loch of Skellister NGR: HU 46566 55905 Description: Well defined small stream. Estimated less than 1m wide by 0.5m deep. Flowing over bed rock</p> <p>CAR Category: Small Catchment Area: 1.70 km² (upstream of crossing location) Ecology: Migratory fish, possible. Mammals, unlikely Crossing Type: Probably requiring upgrading of existing crossing: Rectangular culvert.</p>

Looking across stream	Viking NS15 across 1.jpg	Looking downstream	Viking NS15 down.jpg	Looking upstream

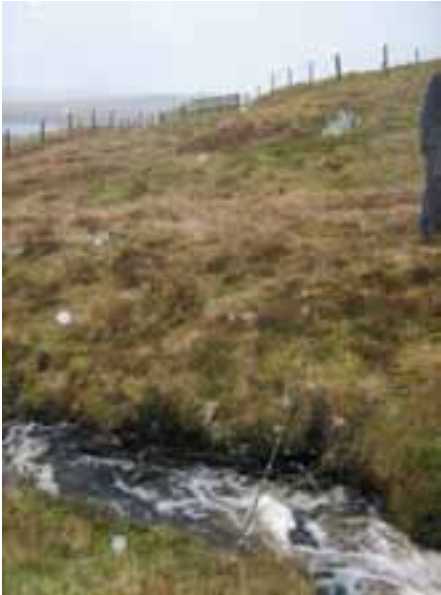
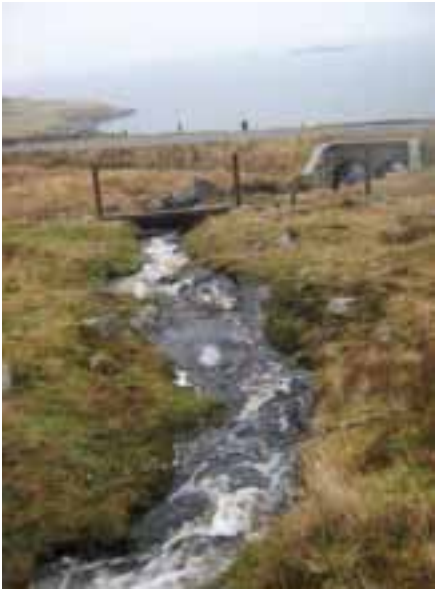
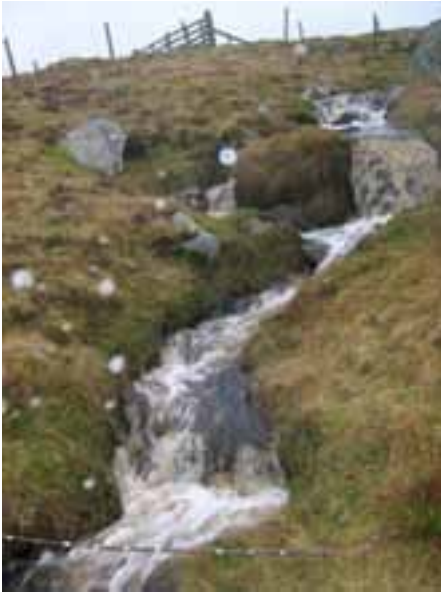
Viking Wind Farm Survey of Stream Crossings		
<div><div><div><div>Crossing:</div><div>Route:</div><div>Catchment ID:</div><div>Watercourse:</div><div>NGR:</div><div>Description:</div></div><div><div>CAR Category:</div><div>Catchment Area:</div><div>Ecology:</div><div>Crossing Type:</div></div></div><div><div>NS16</div><div>Site access track between B9075 and N150</div><div>24</div><div>Unnamed outflow from Loch of Skellister</div><div>HU 46612 55763</div><div>Well defined small stream with good fast flow. 0.4-1m wide by 0.4m deep. Water depth of 0.2m flowing over bed rock. Large exposed boulders on banks. Culverted under existing B9075 road.</div><div>Small</div><div>1.67 km² (upstream of crossing location)</div><div>Migratory fish, likely. Mammals, unlikely</div><div>Probably requiring upgrading of existing crossing: Rectangular culvert.</div></div></div>

<p>Looking across stream</p> <p>Viking NS16 across.jpg</p>

<p>Looking downstream</p> <p>Viking NS16 down.jpg</p>

<p>Looking upstream</p> <p>Viking NS16 up.jpg</p>

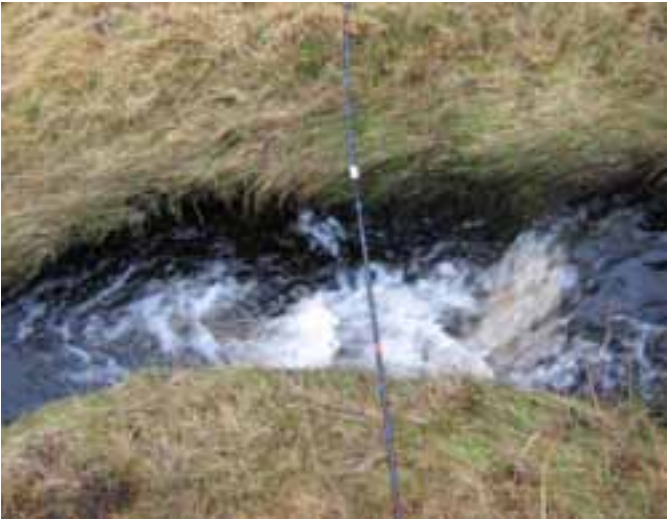
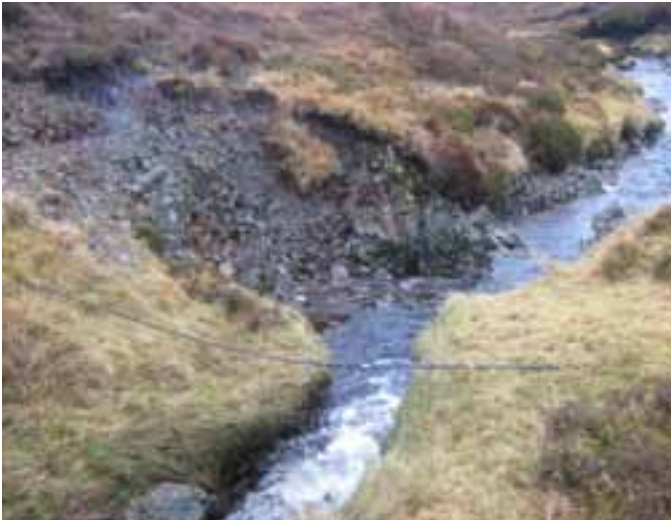
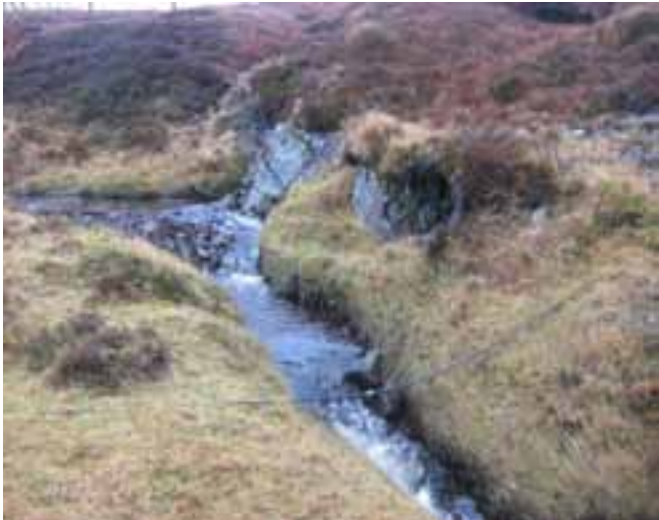
Viking Wind Farm Survey of Stream Crossings		
<div><div>Crossing: NS17</div><div>Route: Between N134 & N136</div><div>Catchment ID: 17</div><div>Watercourse: Burn of Quoys</div><div>NGR: HU 44831 55981</div><div>Description: Small stream, with good flow, channel 0.7m wide by 0.5m deep. Water 0.2m deep. Coarse rocky bed, exposed rock and vegetation on banking.</div></div> <div><div>CAR Category: Small</div><div>Catchment Area: 0.73 km² (upstream of crossing location)</div><div>Ecology: Migratory fish, likely. Mammals, none</div><div>Crossing Type: New crossing: Rectangular culvert / arch</div></div>

<p>Looking across stream</p> <p>Viking NS17 across.jpg</p>

<p>Looking downstream</p> <p>Viking NS17 down.jpg</p>

<p>Looking upstream</p> <p>Viking NS17 up.jpg</p>

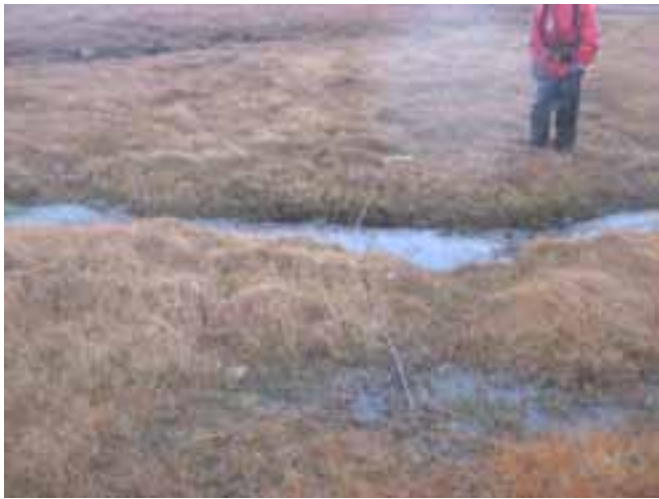
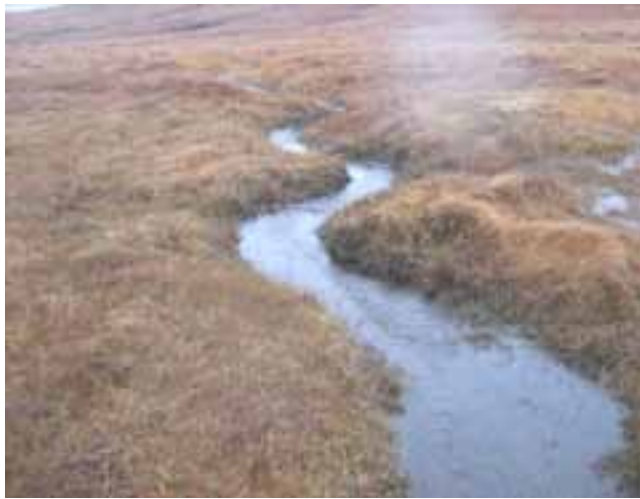
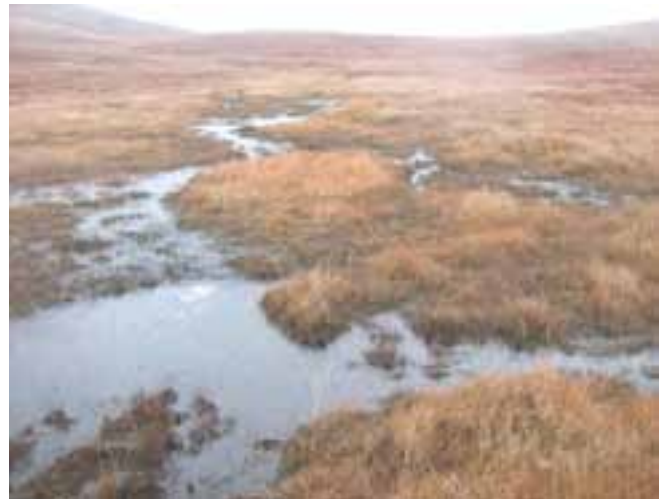
Viking Wind Farm Survey of Stream Crossings			
<p>Crossing: NS18 Route: Between N134 & N136 Catchment ID: 17 Watercourse: Unnamed tributary to Burn of Quoys NGR: HU 44654 55795 Description: Shallow channel, poorly defined in places. Flow area ~0.2-2m wide in broad valley, water 0.2m depth. Vegetation predominantly grasses.</p> <p>CAR Category: Medium Catchment Area: 0.29 km² (upstream of crossing location) Ecology: Migratory fish, none. Mammals, none Crossing Type: New crossing: Drainage layer and pipes</p>

Looking across stream Viking NS18 across.jpg		Looking downstream Viking NS18 down.jpg	
		Looking upstream Viking NS18 up.jpg

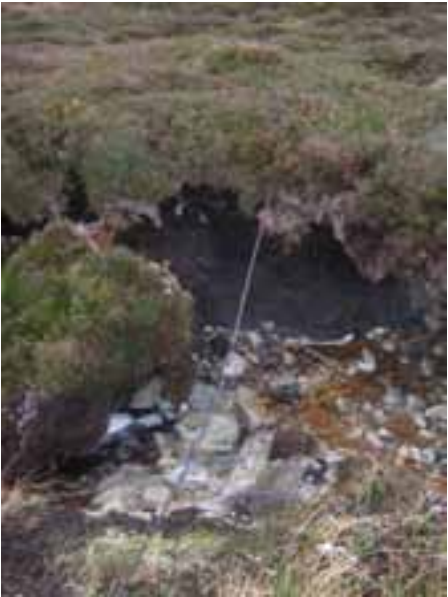
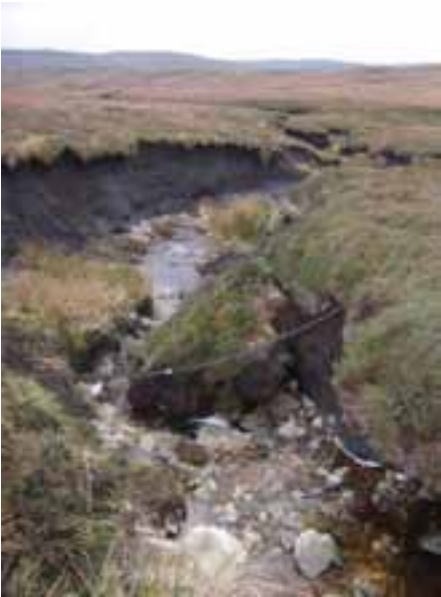
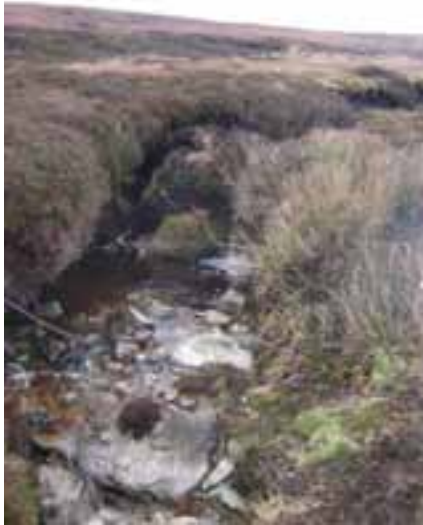
Viking Wind Farm Survey of Stream Crossings		
<div><div><div>Crossing: NS19</div><div>Route: Between N113 & N114</div><div>Catchment ID: 7</div><div>Watercourse: Gill Burn</div><div>NGR: HU 43524 55909</div><div>Description: Medium stream in 1-1.8m wide by 1.1m deep peat channel. Water level 0.2m deep with good flow. Rocky bed and vegetated peat banks.</div></div><div><div>CAR Category: Medium</div><div>Catchment Area: 0.20 km² (upstream of crossing location)</div><div>Ecology: Migratory fish, unlikely. Mammals, none</div><div>Crossing Type: New crossing: Rectangular culvert</div></div></div>

<p>Looking across stream</p> <p>Viking NS19 across.jpg</p>

<p>Looking downstream</p> <p>Viking NS19 down.jpg</p>

<p>Looking upstream</p> <p>Viking NS19 up.jpg</p>

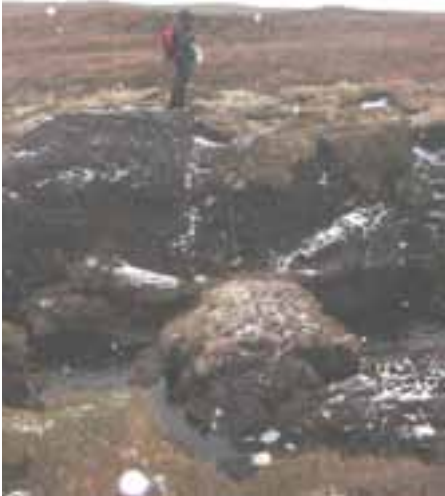
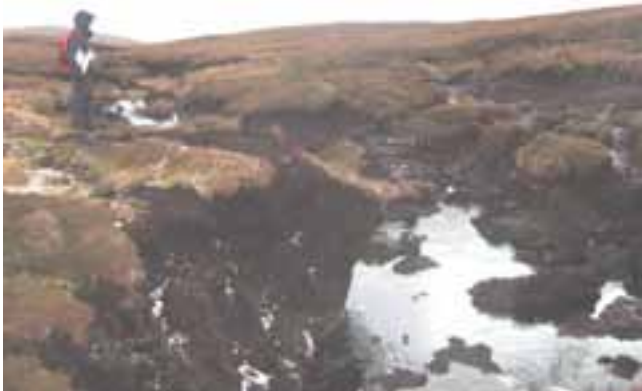
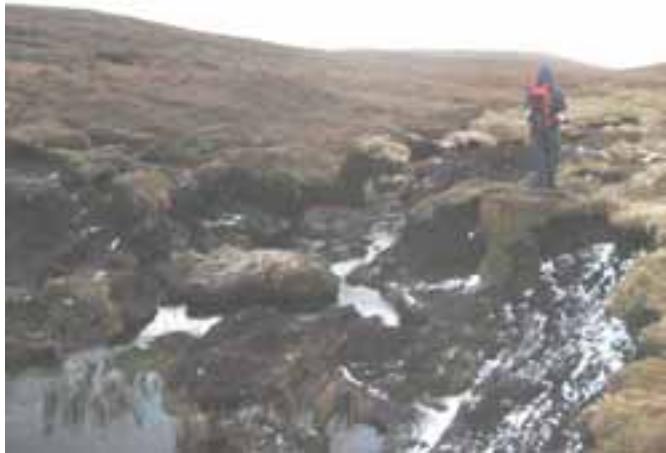
Viking Wind Farm Survey of Stream Crossings		
<div><div><div>Crossing:</div><div>Route:</div><div>Catchment ID:</div><div>Watercourse:</div><div>NGR:</div><div>Description:</div></div><div><div>CAR Category:</div><div>Catchment Area:</div><div>Ecology:</div><div>Crossing Type:</div></div></div> <div><div>NS20</div><div>Between N110 & N111</div><div>7</div><div>Burn of Crookdale</div><div>HU 42494 55690</div><div>Poorly defined channel cut into peat. Up to 5m deep and 2-3m wide. Peaty bed with island areas of peat up to 1m above water level and some large boulders. Water level 0.05m. Peat banking.</div><div>Medium</div><div>0.93 km² (upstream of crossing location)</div><div>Migratory fish, none. Mammals, none</div><div>New crossing: Multiple circular culverts</div></div>	<div>

<div>Looking across stream</div><div>Viking NS20 across.jpg</div></div>	<div>

<div>Looking downstream</div><div>Viking NS20 down.jpg</div></div>	<div>

<div>Looking upstream</div><div>Viking NS20 up.jpg</div></div>
