Kergord Access Track

Peat Landslide Hazard and Risk Assessment

Project no: B1486007
Document title: Peat Landslide Hazard and Risk Assessment
Document No.: B1486007/KAT/PLHRA
Revision: 2
Date: 21 June 2016
Client name: Viking Energy Wind Farm
Client no: Kergord PLHRA
Project manager: J Moran
Author: J Stopford & E Guy
File name: \\GBBHM1-FIL001\Projects\Enr\Ground Management\Jobs\B14860007 Sandwater Rd
Kergord Shetland Peat\Kergord\Report\PLHRA\Kergord Access Track PLHRA REV
2.docx

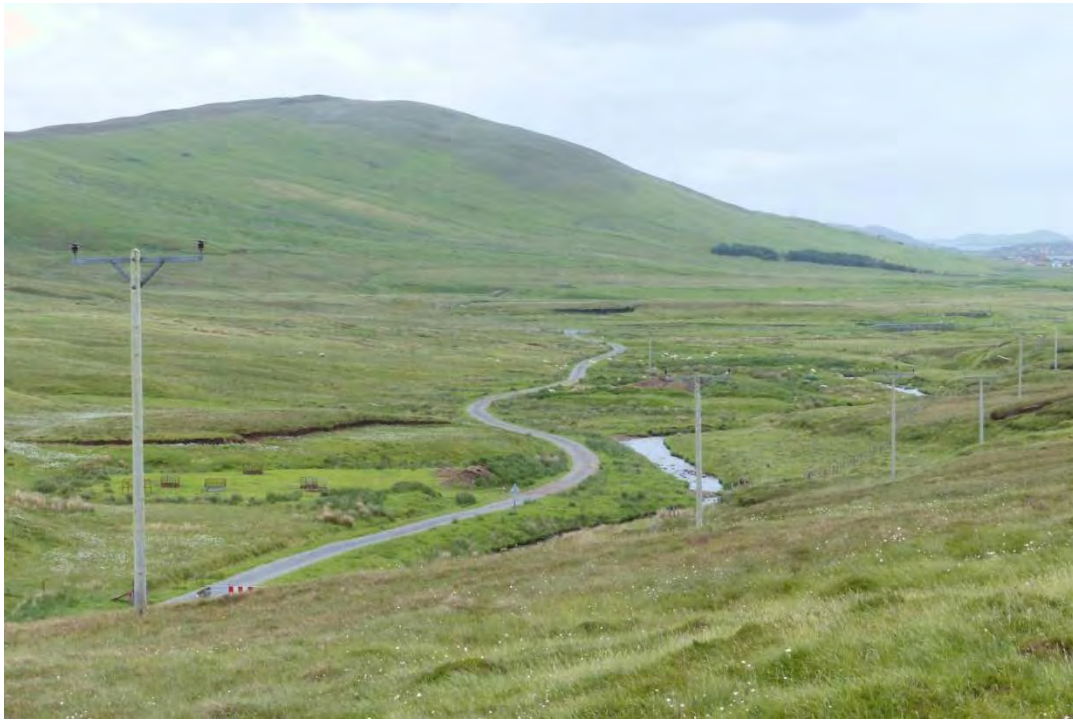
Photo 1 - View looking south across the southern end of the proposed development. Here the track passes through a mix of unimproved and semi-improved pasture close to Burn of Weisdale.

7. At its southern end the route of the proposed development crosses over the Burn of Weisdale and passes through an area of semi-improved pasture (Photo 1) before traversing a large area of open moorland and rough pasture for the remainder of the route to the converter station (Photo 2). From the Upper Kergord Farm buildings and northwards to beyond the proposed location of the converter station the Kergord valley is relatively broad (approx. 500m wide) and flat-bottomed and here the habitats are a mix of damp grassland and blanket bog, habitat that is particularly attractive to several breeding wader species including whimbrel and golden plover.

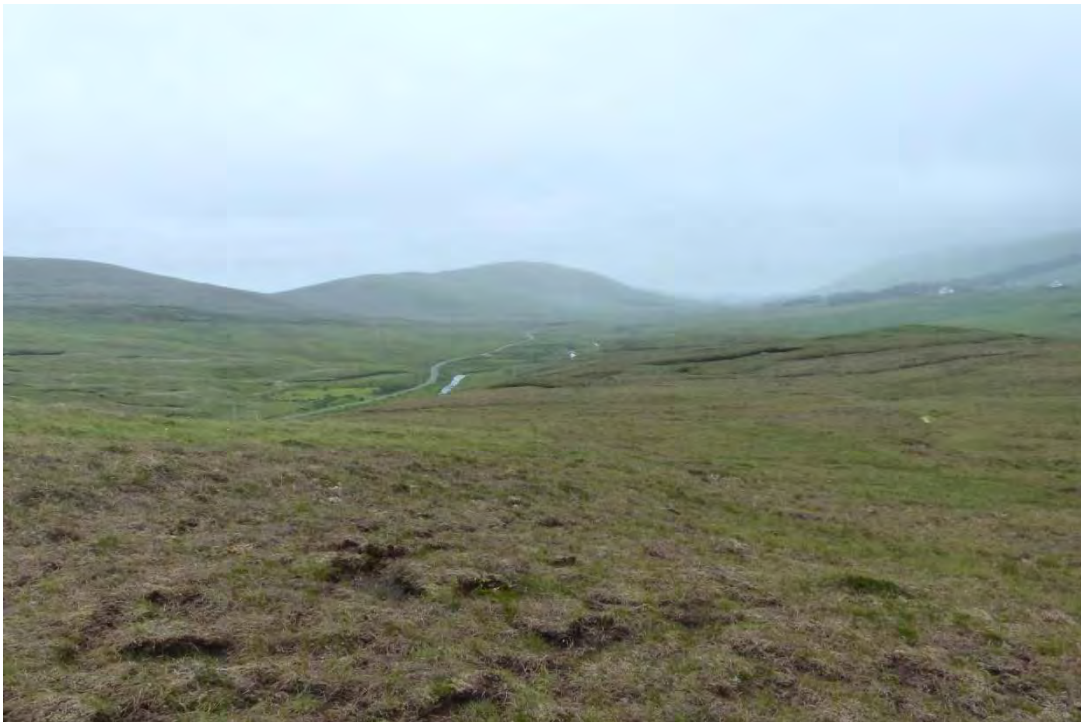
Photo 2 - View looking south across the middle part of end of the proposed development; the proposed alignment approximately follows the crest of the raised ground in the middle ground on the far right of the photo. Here the proposed development passes through open moorland blanket bog habitats.

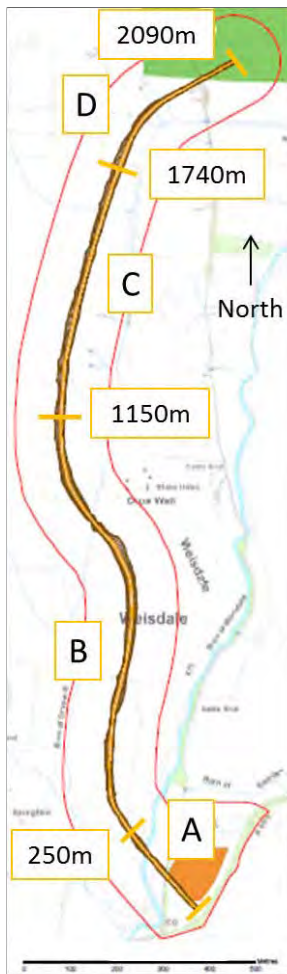
For the purpose of description, the site is considered as four sections of common character, with the extents of each section indicated on the sketch plan shown in Figure 1-2. The Desk Study in Section 2 follows the same convention of zones. The general description of each area is as follows:

- A. The alignment of the proposed development passes through open land used for sheep grazing on the gently sloping eastern valley side then crosses over the existing Upper Kergord track and the Burn of Weisdale.
- B. The alignment of the proposed development passes through open land over a low-lying broad ridge and into the narrow, 'v-shaped' valley along the Burn of Droswall.
- C. The alignment of the proposed development passes along the western valley side, which has steep slopes with frequent small streams. This area appears to have been used historically as crofting land.
- D. The alignment of the proposed development passes through crofting/agricultural land with short grassed area.

Figure 1-2: Diagrammatic plan above showing the proposed alignment of the Kergord Access Track, divided into four areas of common landscape character²⁶.
