Viking Wind Farm Construction Compounds - Main Compound

Environmental Impact Assessment Report

APPENDIX 2.2: OUTLINE CONSTRUCTION TRAFFIC MANAGEMENT PLAN

Peat Landslide Hazard and Risk Assessment Prepared for: Viking Energy Ltd

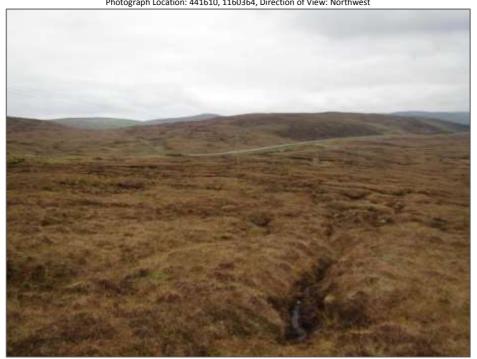
Photograph 2-1

General view of ground conditions at North Construction Compound Photograph Location: 441610, 1160364, Direction of View: Northwest

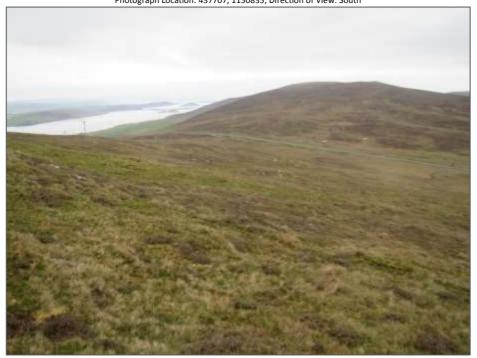
Photograph 2-3

General view of ground conditions at West Construction Compound Photograph Location: 437707, 1150835, Direction of View: South

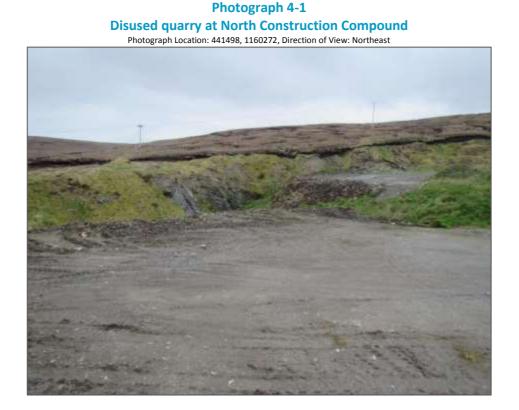
There have been no historic mining or quarrying activities known within the Site boundaries at the Main Construction Compound and West Construction Compound, the site at North Construction Compound has been quarried historically and is currently unrestored – see Photograph 4-1 below.

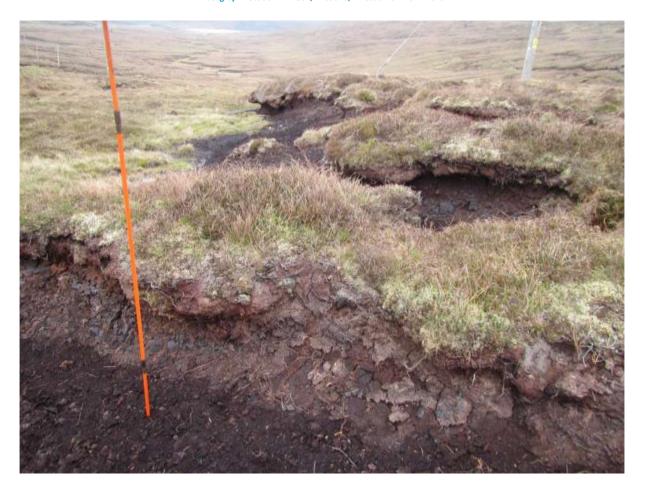
Photograph 6-1

Haggy Peat Deposits – North Construction Compound Photograph Location: 441531, 1160370, Direction of View: North

The peat was found to vary across the site in terms of thickness and coverage. The thickest peat was generally limited to the east of the site. Part of the site is situated on a disused quarry where peat/peaty soils have been removed. The majority of probes (approximately 60%) across both phases of peat probing identified peat (> 0.5 m) of which approximately 29% was classified as thick peat (>1.5 m). The peat identified on site was highly fibrous and often eroded, with peat hags present on site (Photograph 6-1)).

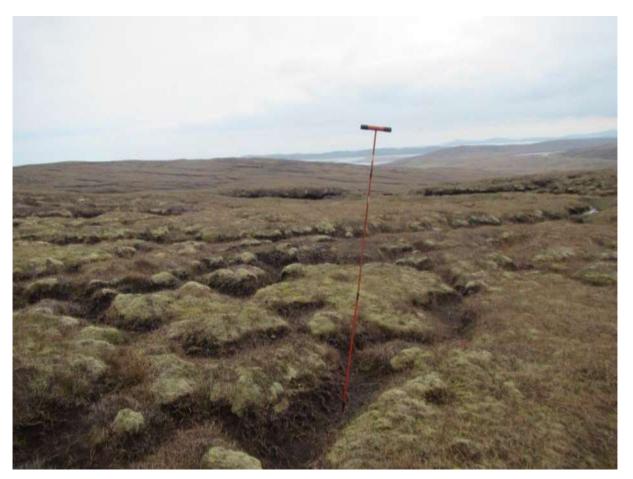
Photograph 6-2 Haggy Peat Deposits – Main Construction Compound Photograph Location: 442116, 1155074, Direction of View: South

The peat found on the Main Construction Compound site was generally consistent in coverage and thickness with the thickest peat situated to the north and west of the site. The majority of probes (approximately 90%) across both phases of peat probing identified peat (greater than >0.5 m) with 34% of all probes intersecting thick peat (>1.5m). The peat identified on site was highly fibrous and often eroded with peat hags present on site Photograph 6-2.

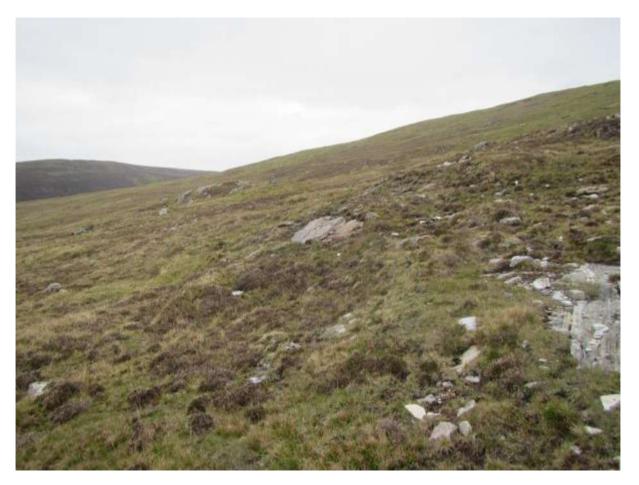
Photograph 6-3

Bedrock outcropping – West Construction Compound Photograph Location: 437637, 1150680, Direction of View: North

- Approximately 12% of peat probes undertaken across the entire site found soils in excess of 0.5 m thick and no greater than 1.0m;
- Peat is very limited across the West Construction Compound site with thin soils over shallow rock prevalent.
