Appendix 10.1 – Water Crossing Schedule

Table 1: Surveyed Watercourse and Ditch Locations (Baseline)

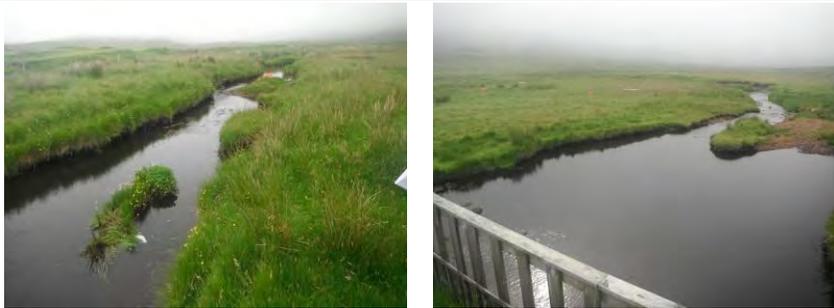
Label	Grid Reference	Name	Approximate Channel Width (m)	Approximate Channel Depth (m)	Site Observations
A	440104, 1154793	Burn of Weisdale (Upstream of existing bridge)	4m	0.6m	Moderate flow rate observed Substrate: Pebbles and Cobbles Existing Bridge consists of five metal lined culverts through a concrete structure

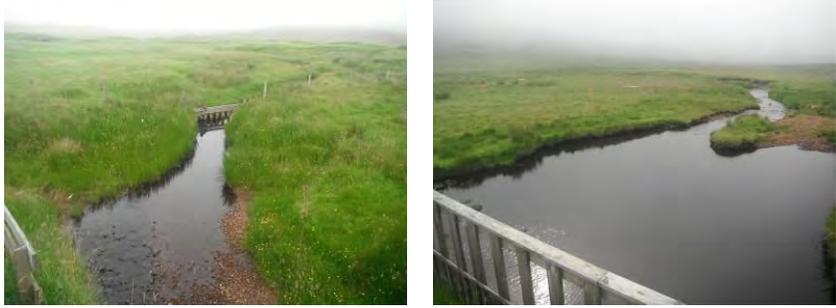
B	440071, 1154789	Unnamed	1.2m	0.6m	Low flow rate observed Substrate: Predominantly gravel Discharges into the Burn of Weisdale immediately upstream of the Bridge at Locations A

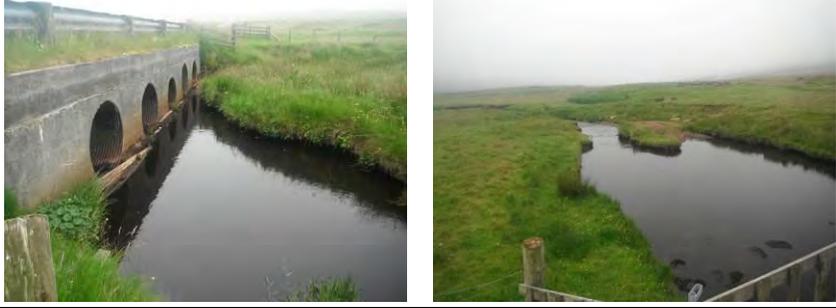
C	440105, 1154757	Burn of Weisdale (Downstream of existing bridge)	12m	0.5m	Low flow rate observed Substrate: Pebbles and Cobbles Existing Bridge consists of five metal lined culverts through a concrete structure

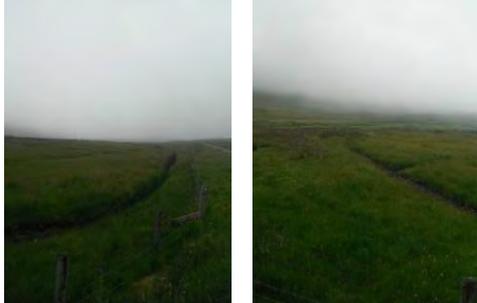
G	440268, 1154895	Unnamed ditch	0.5m	0.3m	Low flow rate observed Substrate: Bog/peat with gravel
<p>Downstream (North):</p>

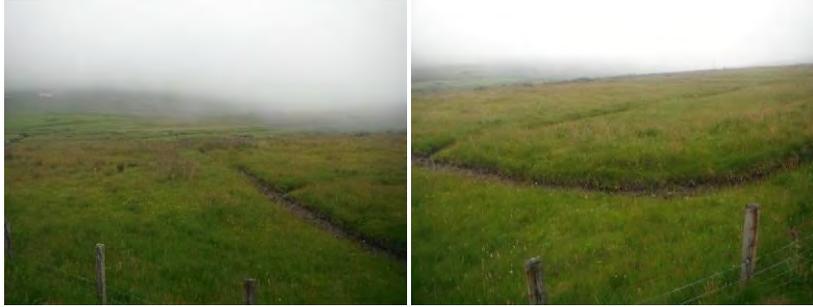
H	440306, 1154890	Unnamed ditch	0.5m	0.3m	Low flow rate observed Substrate: Bog/peat with gravel Existing highway cross drain consists of a square stone culvert
Upstream (South):

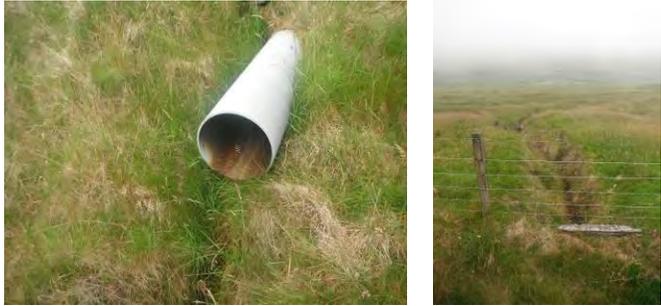
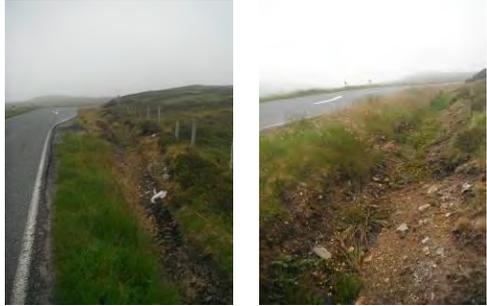
I	440466, 1155088	Burn of Swirtars	0.8m	0.5m	Low flow rate observed Substrate: Bog/peat with gravel Existing highway cross drain consists of a 0.3m diameter pipe
North:			South:

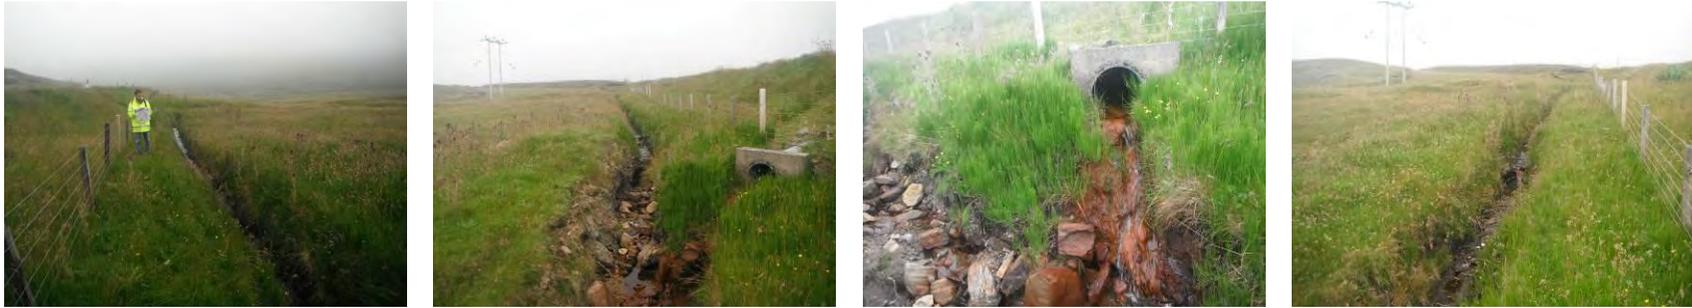
J	440596, 1155172	Unnamed ditch	0.5m	1.5m	Moderate flow rate observed Substrate: Bog/peat with coarse gravel

Label	Grid Reference	Name	Approximate Channel Width (m)	Approximate Channel Depth (m)	Site Observations
					Existing highway cross drain consists of a 0.5m diameter pipe
North:

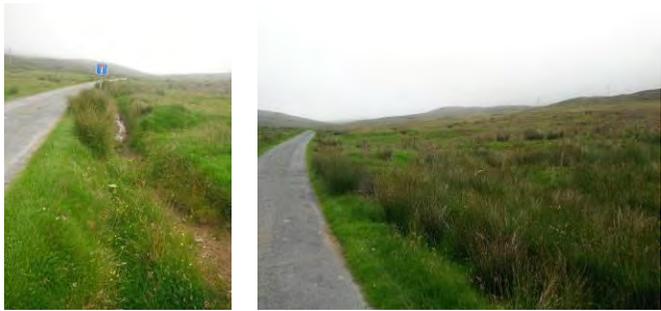
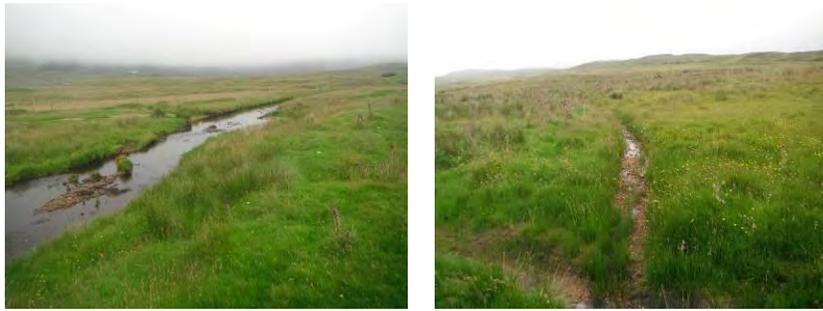
K	440138, 1154974	Unnamed ditch	0.5m	0.5m	Moderate flow rate observed Substrate: Bog/peat with coarse gravel Existing highway cross drain was not visible due to heavy vegetation
East:			West:

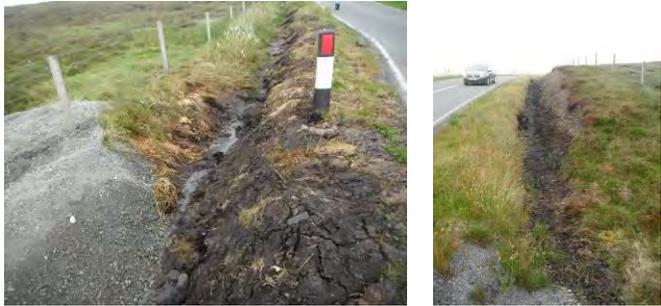
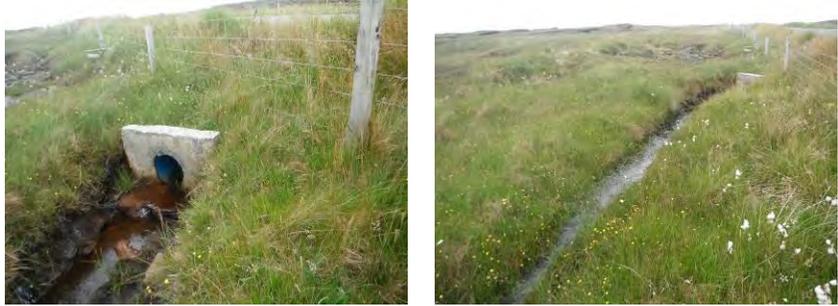
Label	Grid Reference	Name	Approximate Channel Width (m)	Approximate Channel Depth (m)	Site Observations
L	440992, 1154930	Unnamed ditch	0.5m	0.5m	Moderate flow rate observed Substrate: Bog/peat with gravel Existing highway cross drain consists of a 0.3m diameter pipe
Upstream (North):			Downstream (South):

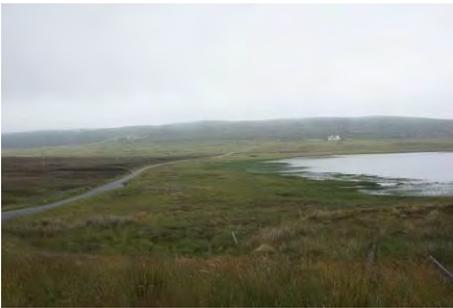
Label	Grid Reference	Name	Approximate Channel Width (m)	Approximate Channel Depth (m)	Site Observations
N	441228, 1155106	Unnamed ditch	0.5m	0.5m	Moderate flow rate observed Substrate: Bog/peat with gravel Existing highway cross drain consists of a 0.3m diameter pipe
Upstream (North):			Downstream (South):		
O	441305, 1155146	Unnamed ditch	0.5m	0.5m	Moderate flow rate observed Substrate: Bog/peat with gravel

Label	Grid Reference	Name	Approximate Channel Width (m)	Approximate Channel Depth (m)	Site Observations
					Existing highway cross drain consists of a 0.3m diameter pipe
Upstream (North):

Downstream (South):

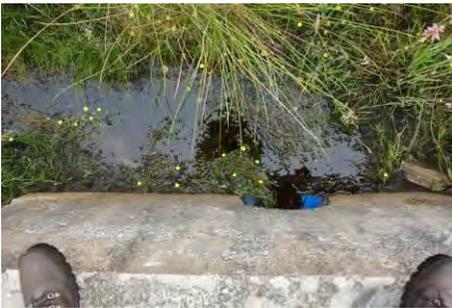
P	441325, 1155162	Unnamed ditch	0.5m	0.5m	Moderate flow rate observed Substrate: Bog/peat with gravel Existing highway cross drain consists of a 0.3m diameter pipe
Upstream (North):

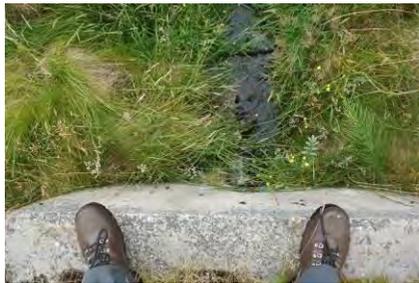
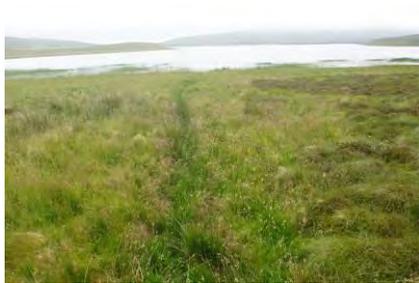
Downstream (South):

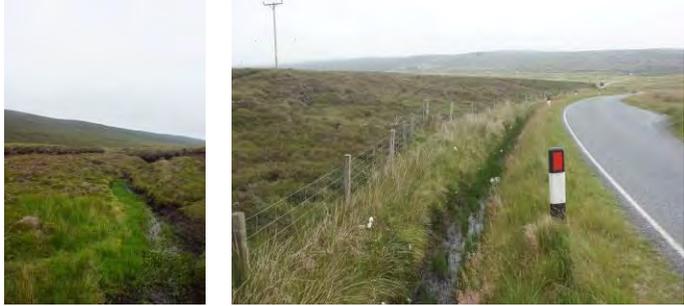
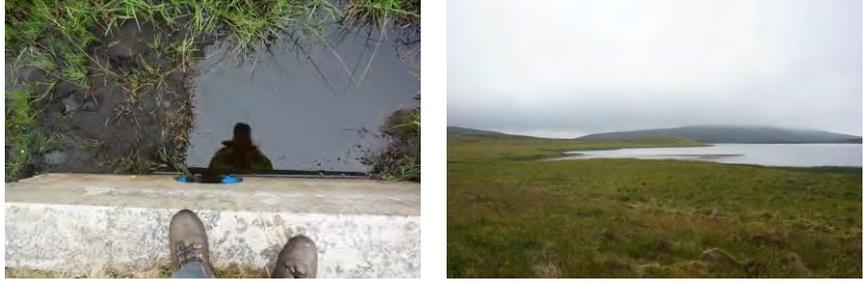
Label	Grid Reference	Name	Approximate Channel Width (m)	Approximate Channel Depth (m)	Site Observations
Q	441347, 1155179	Unnamed ditch	0.5m	0.5m	Moderate flow rate observed Substrate: Bog/peat with gravel Existing highway cross drain consists of a 0.3m diameter pipe
Upstream (North):			Downstream (South):

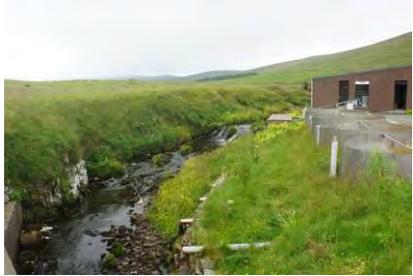
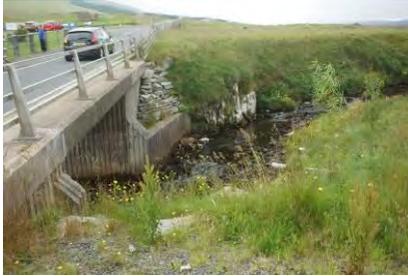
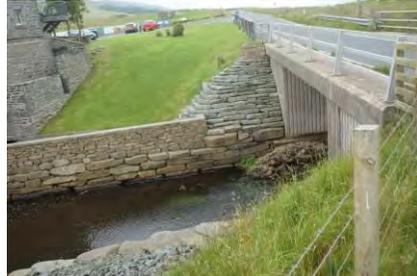
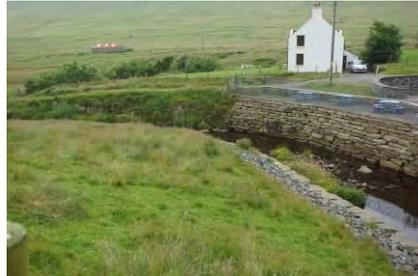
R	441549, 1155282	Burn of Sandwater (Upstream of existing Bridge)	7.0m	2.0m	Moderate flow rate observed Substrate: Pebbles and Cobbles Bridge consists of a single box culvert with concrete soffit 1.5m above observed water level and stone and mortar sides.

Label	Grid Reference		Name	Approximate Channel Width (m)	Approximate Channel Depth (m)	Site Observations
S	441547,	1155216	Burn of Sandwater (Downstream of existing Bridge)	6.0m	2.0m	Description: Same as Location R
T	439513,	1153057	Burn of Weisdale	6.0m	4.0m	<p>Good flow observed</p> <p>Substrate: Pebbles and Cobbles</p> <p>Bridge consists of a single box culvert with concrete soffit 3.5m above observed water level and stone and mortar sides.</p>
Upstream (East):				Downstream (West):
